NRL Report 6387

Investigation of the Intergranular Corrosion of Lead-Antimony Grid Alloys

A. C. SIMON

April 7, 1966

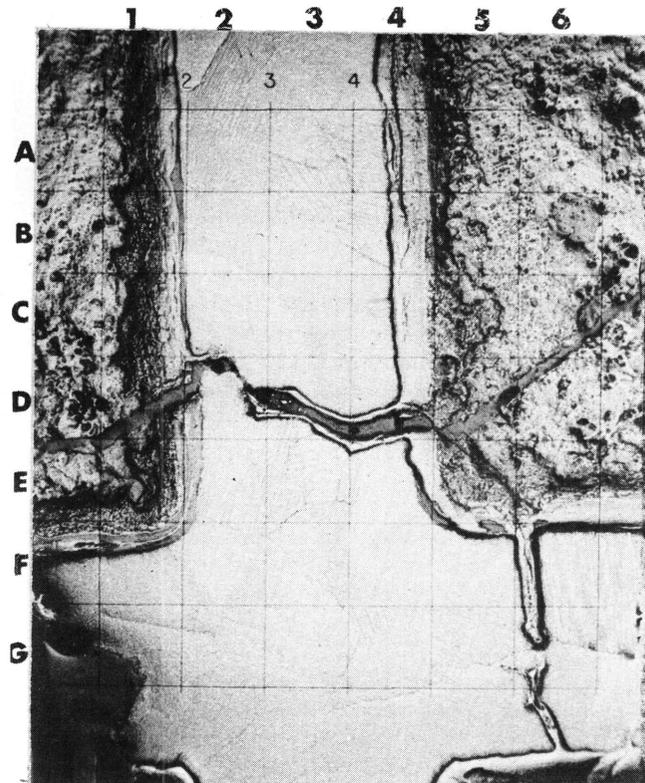
Fig. 1 - A cross section of the junction of two grid members. The photograph shows two major examples of intergranular grid corrosion as found in the 10-year-old battery. A portion of the corrosion layer along the surface of the grid and some of the surrounding active material are also shown. Lines forming the squares are 550 microns apart and the original magnification is 20X.

Figure 1 illustrates several features of this intergranular corrosion that should be mentioned. Although not clearly visible at this magnification, all corrosion resulting in cracking proceeded along grain boundaries, often by rather devious paths. This will be illustrated in later photomicrographs. Although intergranular corrosion cracks could initiate at almost any grain boundary intersecting the surface of the grid, the worst cases were always near the junction of two grid members. At the same time only a small portion of all the grain boundaries that intersected the surface, even at such an intersection of two grid members, showed evidence of such a localized attack.

The crack that crosses the grid at D2, D3, and D4 of Fig. 1 has completely severed the grid, and actual separation has occurred, the space between the two sections being filled with the plastic used in the impregnation. The crack itself extends through the grid, the corrosion product at each side of the grid, and into the active material. There have also been lateral and vertical displacements of the two portions of the grid member. It is concluded that the grid sections were displaced after the plate was removed from the cell and dried, and that this caused cracking of the active material. It seems unlikely that the wet active material would exhibit such a clean fracture. Figure 2 is an enlarged view of D2

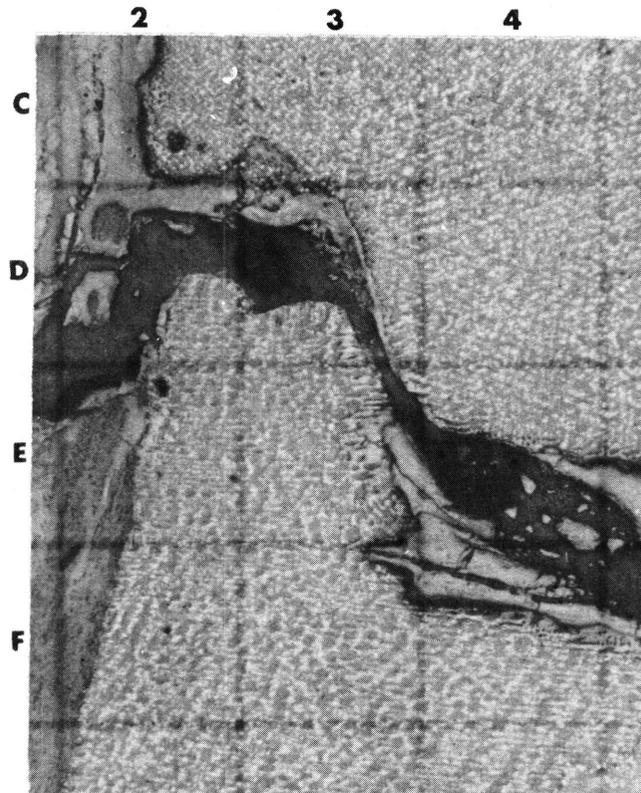
Fig. 2 - A cross section showing an enlargement of D2 of Fig. 1. Note the different microstructure in the grains on each side of the crack, the lateral displacement that occurred during removal of the plate from the cell, and the lack of corrosion product on the metal at the lower edge of the crack in D3 and on the upper edge of the crack in E4. Surface corrosion appears in C2, D2, E2, and F2. Interdendritic corrosion appears near the junction of D3 and E3. Lines forming the squares are 238 microns apart and the original magnification is 100X.

in Fig. 1. D2 and D3 of Fig. 2 show corrosion on only one side of the crack, also indicating that the grid segments were displaced after removal of the plate from the cell. Otherwise such an unprotected metal surface would show a definite corrosion layer. A similar condition can be seen in the upper left portion of E4 in Fig. 2.

Figure 2 shows that the two sections of the grid have been displaced vertically and laterally so that the portion of the crack shown in D3 and E4 has been narrowed somewhat and the areas formerly adjacent are no longer so. This area is shown at somewhat higher magnification in Fig. 3. Casual inspection might suggest that here also there is very little corrosion on either side of the crack. Closer inspection reveals a thin layer of slightly darker material along each side of the crack and parallel bands in D3 and E3 that are longer than the bright particles of antimony in the surrounding metal. Figure 4 represents the same area at

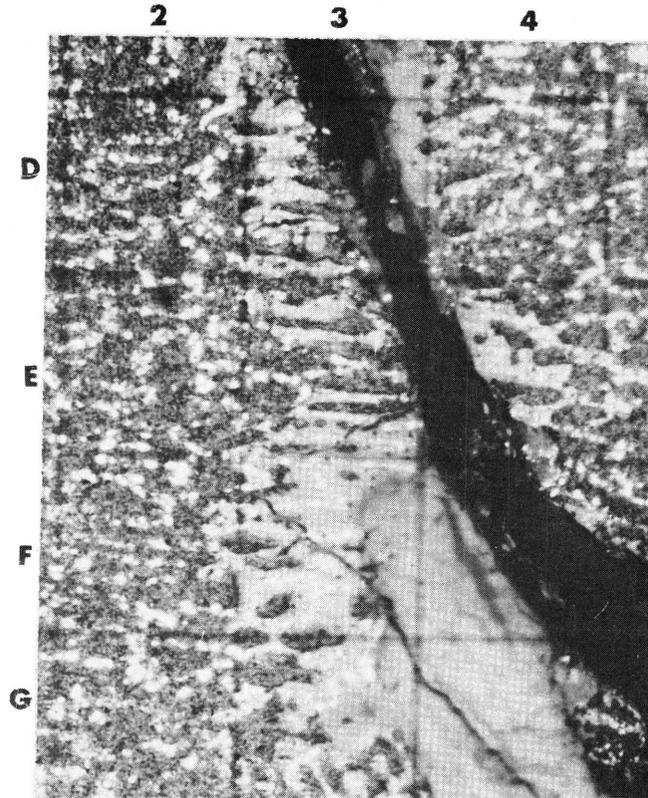
Fig. 3 - An enlargement of D3 and E3 in Fig. 2. Note the interdentritic corrosion adjoining the crack in areas D3, D4, E3, and E4. Also note the different type of corrosion product in F4 and G4 and the thin layer of still another type of corrosion product adhering to each side of the crack in D3. Lines forming the squares are 60 microns apart and the original magnification is 400X.

Figures 3, 14, 16, and 17 illustrate the relative widths of the primary dendrites (dark gray portions) in relation to the zone of impurity or eutectic (the area containing the bright shiny particles) and show that these precipitated particles are confined to a relatively narrow strip between considerably wider adjacent primary dendritic branches. It is cautioned that these photomicrographs are cross sections and it should be borne in mind that the primary dendrite branches are really parallel, nearly cylindrical bodies and are completely surrounded by a thin shell of the zone containing the bright particles of antimony. If a narrow zone of precipitated particles is left between adjacent dendritic arms of the primary growth, then a similar strip should be left between the advancing arms of dendrites growing from different nuclei or, in other words, at the grain boundary. Generally this was true and a line of such particles was distributed along the grain boundary.

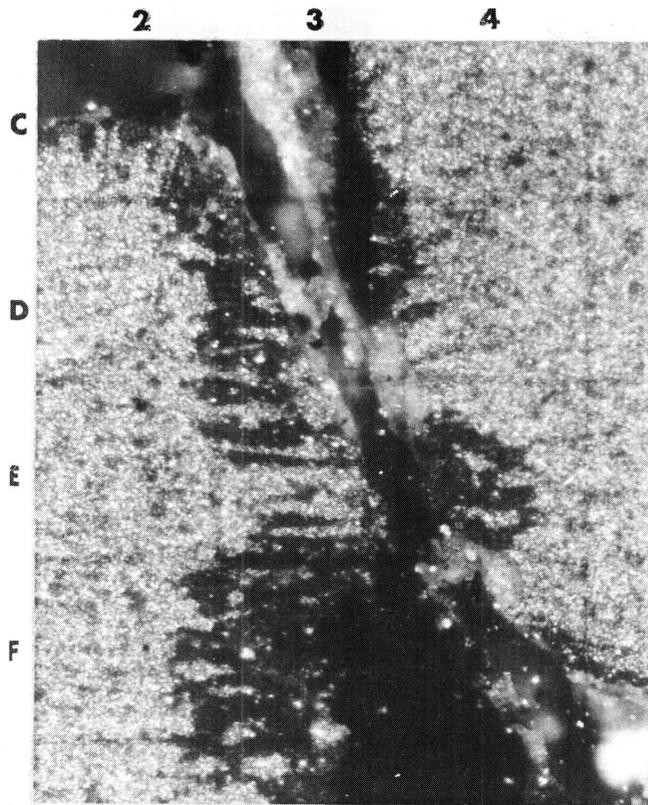
Fig. 4 - Same as Fig. 3 except viewed with polarized light. Lines forming the squares are 60 microns apart and the original magnification is 400X.

the same magnification but illuminated with polarized light. In this picture it can be more clearly seen that extensive lateral corrosion has taken place in a manner that definitely indicates interdendritic corrosion as the dark material in D3, E3, E4, F3, and G3 shows. In addition, comparison of Figs. 3 and 4 reveals that the material along the edge of the crack in F4 and G4 of both photographs differs in appearance from that which occurs in regions of interdendritic corrosion as found in such areas as D3 and E3.

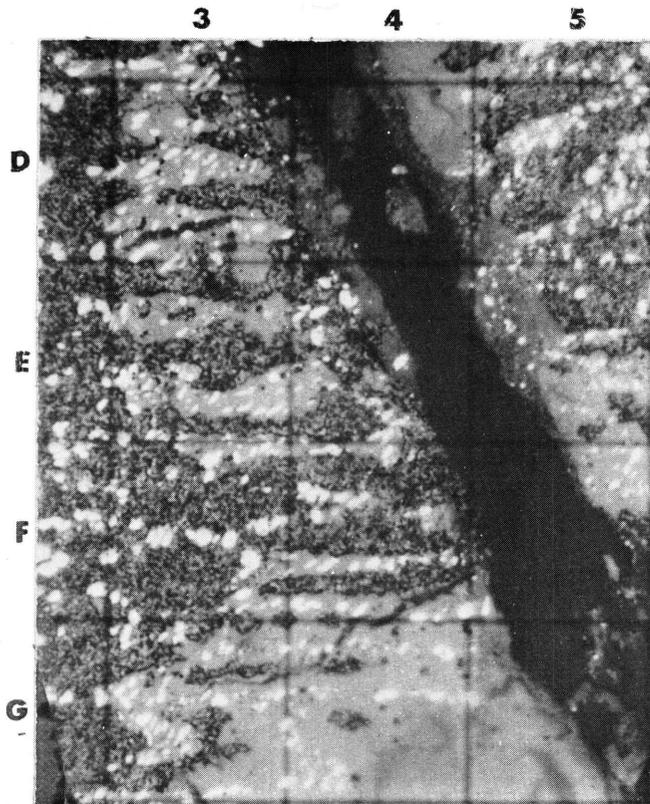
Fig. 5 - A magnified view of D3 and E4 in Fig. 3. Note that the bright antimony particles in the interdendritic corrosion product are still present and that they mark the limit of the light-colored corrosion product in G4. Comparison with Figs. 4 and 5 shows that the darker material contains no antimony particles. Lines forming the squares are 30 microns apart and the original magnification is 800X.

This area of interdendritic corrosion is shown at still higher magnification in Figs. 5 and 6. Figure 5, taken with vertical illumination, shows that antimony particles are still present in the interdendritic corrosion pockets and that the corrosion product at the edge of the crack is quite different from that within the pockets of dendritic corrosion. Although it cannot be seen from this photograph, the corrosion product at the edge of the crack is also different from that found at the surface of the grid and in portions of the crack open to electrolyte flow. Figure 6 shows this area under polarized light. The photograph imperfectly shows detail that is readily apparent with the benefit of color. It can be seen that the crack is open and filled with plastic. At each side is a layer of light gray-appearing material, whereas the corrosion in the interdendritic pockets is much darker and that at the surface of the grid would appear jet black if visible. This gray-appearing material when seen under polarized light is actually an area of very light yellow mixed with red or almost white material and is composed of individual particles that are usually but not always translucent.

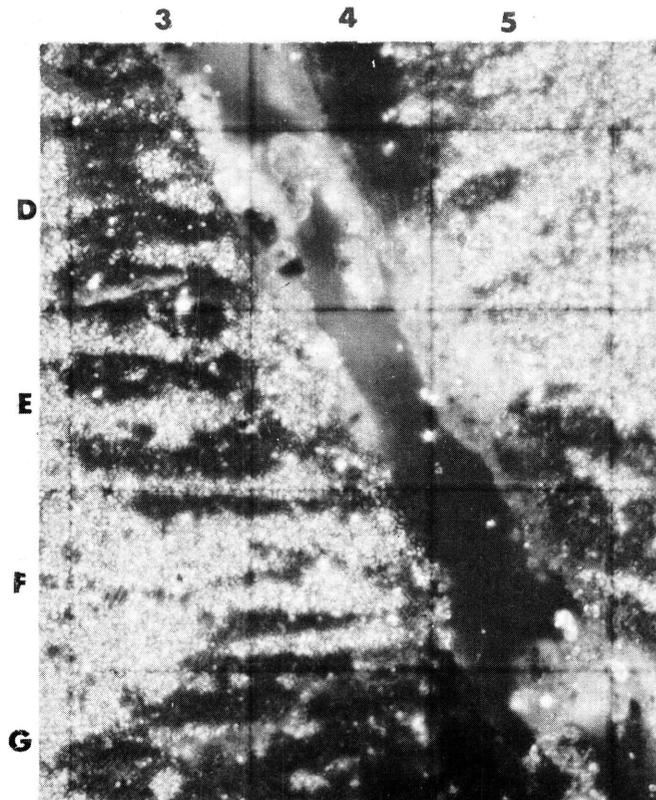
Fig. 6 - Same area as Fig. 5 except viewed with polarized light. Compare with Fig. 5 for the extent of interdendritic corrosion. Note that the material along the surface of the crack and the interdendritic corrosion have different appearances. Lines forming the squares are 30 microns apart and the original magnification is 800X.

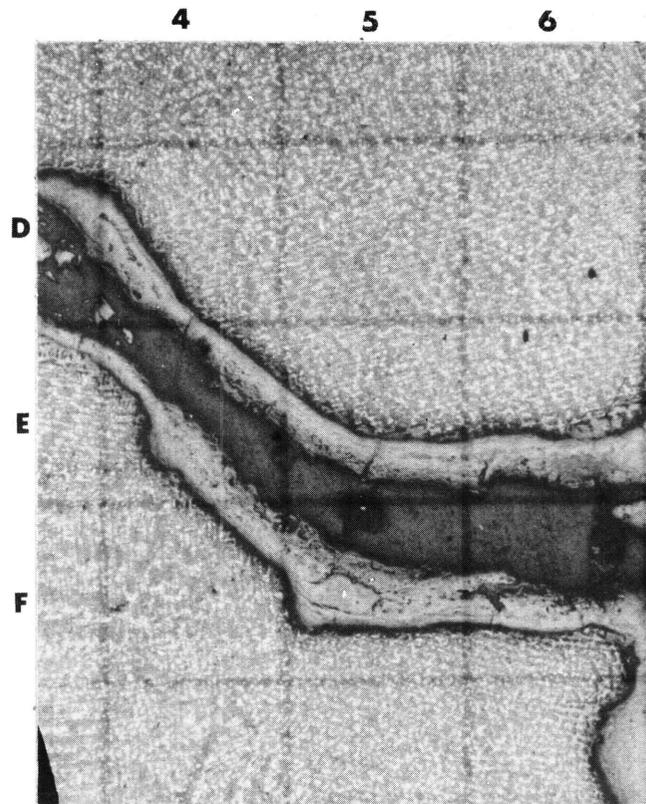
Fig. 7 - Same area as in D3, D4, E3, and E4 of Fig. 1 but at higher magnification. It will be noted that the corrosion here is similar to that at the surface of the grid and that there is no interdendritic corrosion. Lines forming the squares are 238 microns apart and the original magnification is 100X.

Figure 7 is an enlargement of the portion of the crack that falls in D4 and partially in D3 of Fig. 1. This portion of the crack shows no penetrating interdendritic corrosion, and the type of corrosion here is similar to that found along the surface of the grid. It is probable that this portion may have actually cracked open during operation.

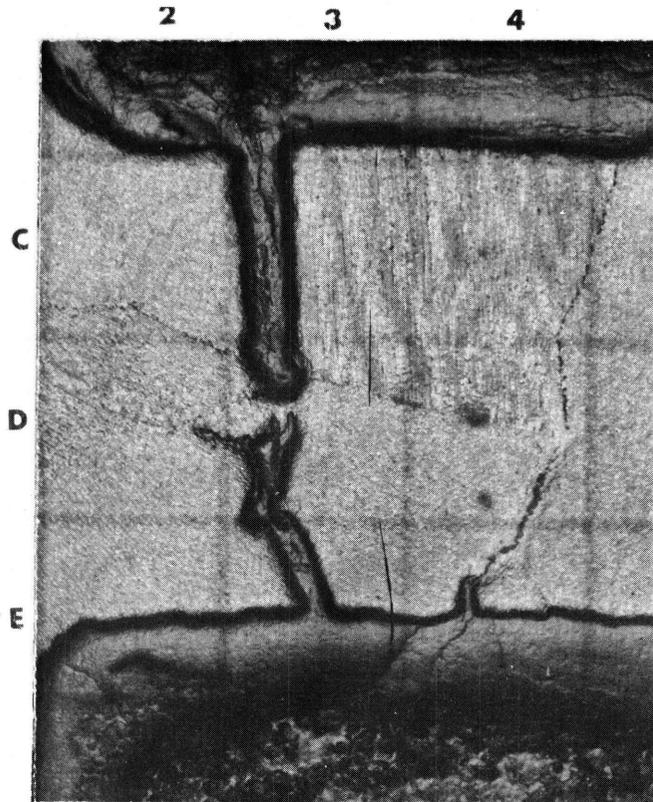
Fig. 8 - A magnified view of F6 and G6 in Fig. 1. The grid has not yet cracked at this point, since the corrosion product at the surface remains intact. Corrosion has proceeded from both sides of the grid along grain boundaries to a near junction at D3, but the long narrow grain in the center does not offer a convenient boundary along which the process can proceed. Lines forming the squares are 476 microns apart and the original magnification is 50X.

However, Fig. 8, a somewhat more higher magnified view of the other example of intergranular corrosion at the lower right of Fig. 1, shows that this is not necessarily the case. In this figure the area appears to be entirely filled with corrosion product and there is no indication that the area of intergranular corrosion on the lower side has any internal separation or that the corrosion product is cracked.

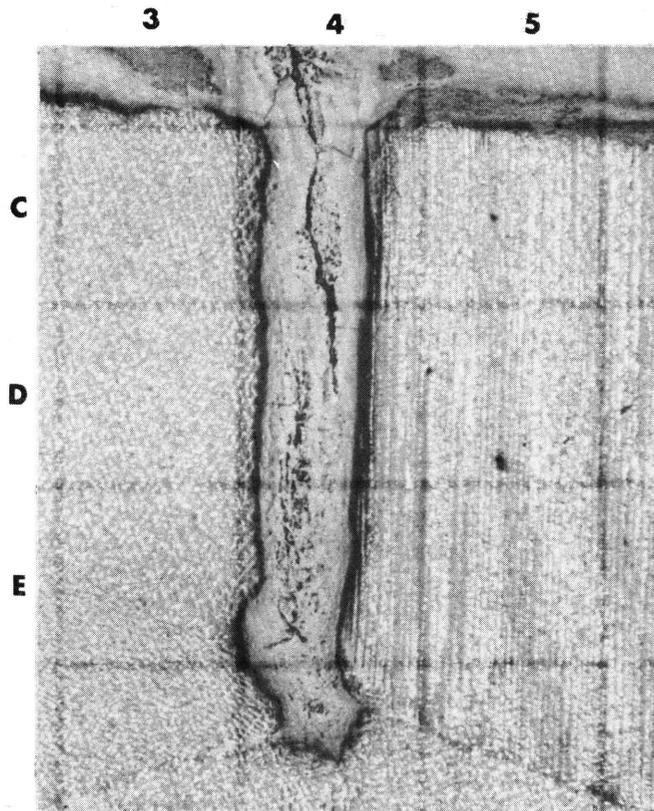
Fig. 9 - The upper portion of the corrosion shown in Fig. 8. The corrosion is intergranular and the grain at the bottom of the photograph has temporarily blocked further extension. Lines forming the squares are 238 microns apart and the original magnification is 100X.

Figure 9 shows the portion of the intergranular corrosion that occurs in C3 and D3 of Fig. 8. It can be seen from the surrounding microstructure that the corrosion has definitely followed the grain boundary between the two adjoining grains and has been slowed against the boundary of a grain at right angles to the path of the corrosion. The obstructing grain offers no boundary for extension of the intergranular corrosion except in a direction nearly parallel to the surface. Throughout this study no cracks proceeded very far in a direction nearly parallel to the surface, and this photomicrograph shows no exception.

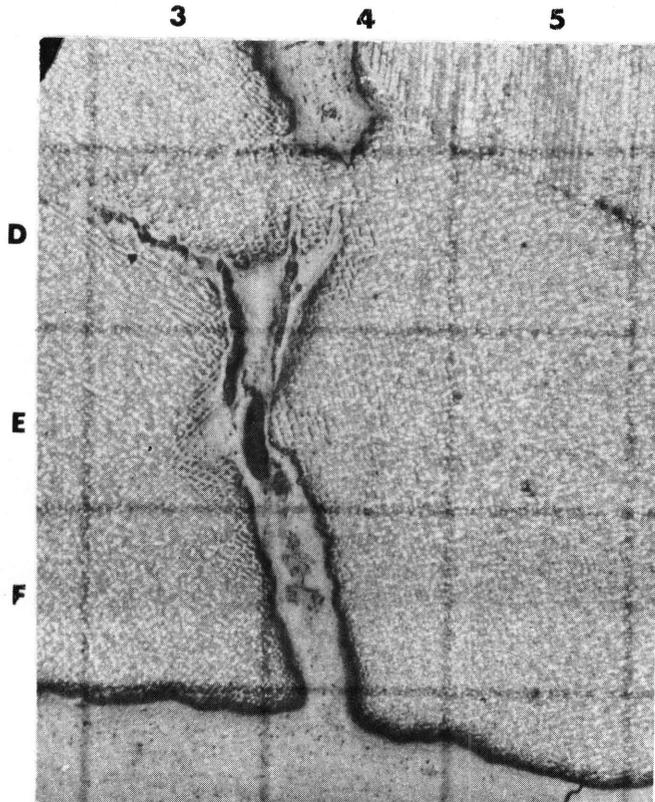
Fig.10 - The lower portion of the corroded area shown in Fig. 8. Again note the different orientations of the grains bordering the corroded area and the corrosion that has proceeded only a short distance along the grain boundary in D3 that is roughly parallel to the surface. Corrosion has also become interdendritic in several areas. Lines forming the squares are 238 microns apart and the original magnification is 100X.

Figure 10 shows the portion of intergranular corrosion below that of Fig. 9 and represented by D3 and E3 of Fig. 8. Here also the corrosion is proceeding inward along a grain boundary but has also taken a short incursion along another grain boundary across D3 of Fig. 10. At this magnification it may appear that there is also a grain boundary in the upper left-hand quarter of D4 and that corrosion may be proceeding along it to a junction with the corrosion above.

The rather large cracks in the intergranular corrosion of Fig. 10 are somewhat puzzling. Since the corrosion product occupies more volume than the alloy, one would suppose that this space would be completely filled and that the corrosion product would be exerting considerable stress on the surrounding areas. Since no cracks appear in the lower portion nearer to the surface of the grid it is supposed that this portion is exerting pressure that causes the inner portion to crack before it has corroded to the same extent. Notice for example that a quite large crack occurs at the lower right of D3 of Fig. 10, as if the leverage of the corrosion product in F4 might be literally prying out the grain to the left of F4.

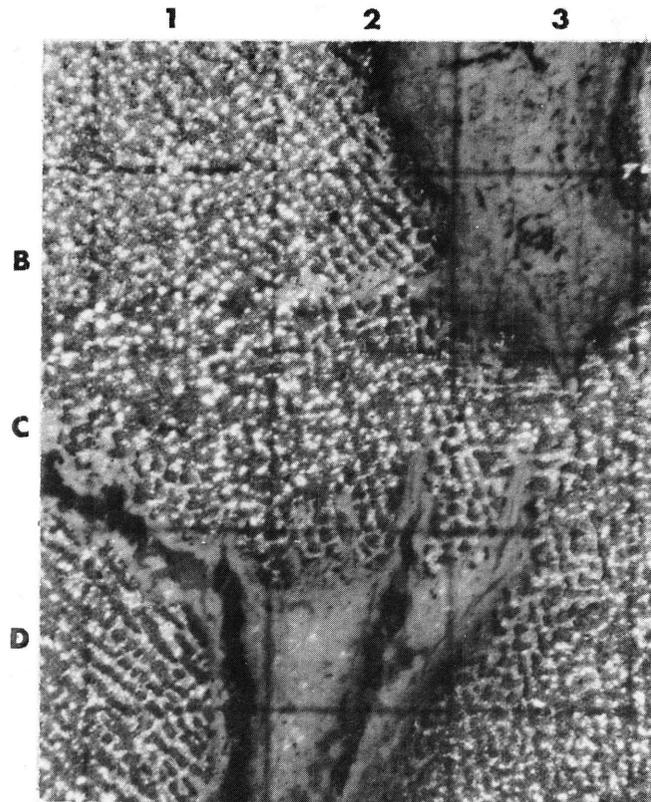
Fig. 11 - A magnified view of D3 and D4 of Fig. 10. Note the interdendritic corrosion that extends from this area and also that the two nearly parallel cracks do not follow interdendritic channels but proceed across them as if directed by stress. Lines forming the squares are 95 microns apart and the original magnification is 250X.

However, a magnified view of this area (Fig. 11) does not indicate the existence of such a boundary, and the fact that corrosion is proceeding toward the upper corroded area along several parallel channels argues against there being one in this area. There is rather extensive interdendritic-type corrosion at the ends of both cracks. Its true extent can be more clearly seen in Fig. 12, which shows the same area as it appears in polarized light. In this cross section it would seem that interdendritic corrosion from the two sides of the obstructing grain may have already merged.

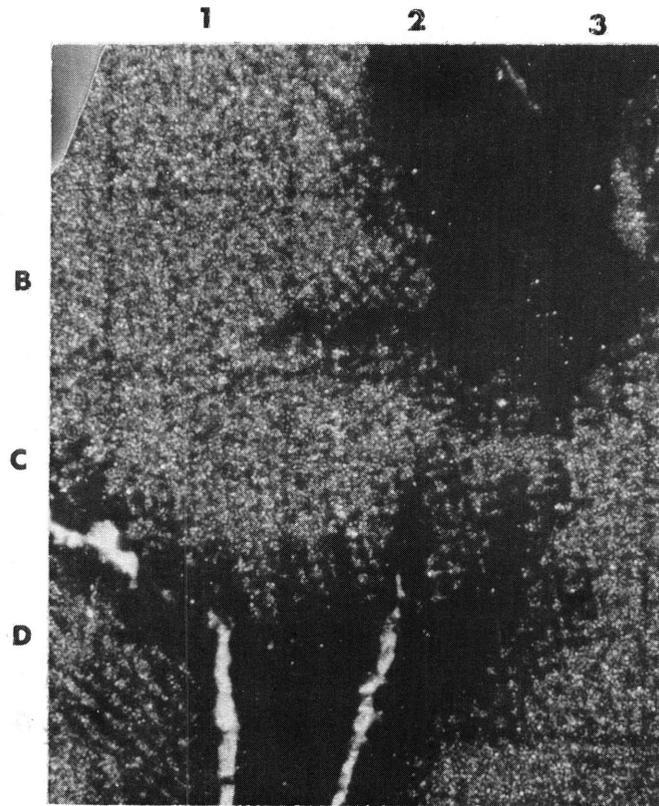
Fig. 12 - Same area as shown in Fig. 11 but illuminated with polarized light. Note the extensive interdendritic corrosion and the two large cracks in the lower corrosion product. Lines forming the squares are 95 microns apart and the original magnification is 250X.

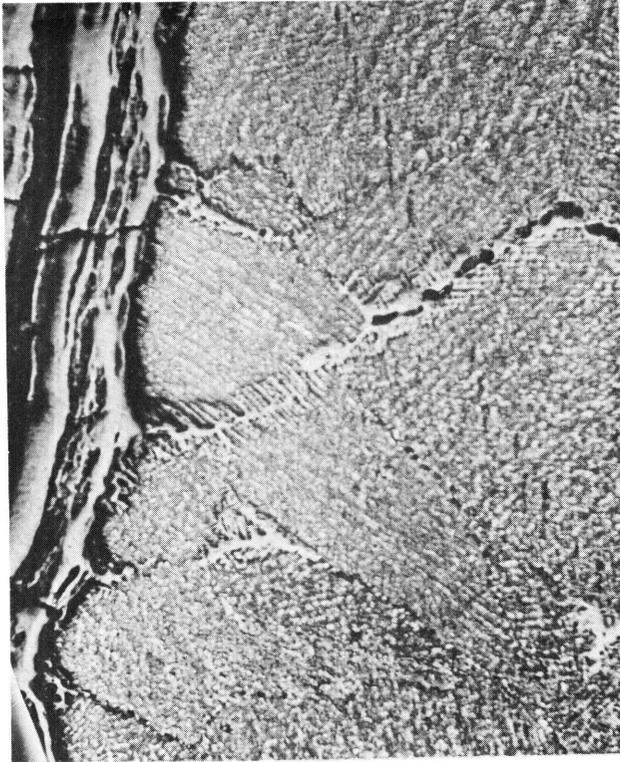
Fig. 13 - An example of interior stress. The wedge-shaped grain to the left of center has developed intergranular corrosion on each side. The increased volume due to corrosion product has resulted in stress cracking at an interior grain boundary (right of center). Original magnification is 100X.

Figure 13 shows a case where corrosion along each side of the wedge-shaped grain at the surface has caused sufficient internal stress so that an actual crack has formed, farther from the surface. The crack does not extend to the surface along either side of the wedge-shaped grain. Also, corrosion has occurred along both sides of the open crack and there seems to be no positive way of telling whether this happened before or after the crack itself developed. There were also cases in which internal cracking at the grain boundary occurred without evidence of corrosion having preceded it in the area. It appears that the internal stress produced by the corrosion in a portion of the grain boundary forms a wedge that is sufficiently strong to pry apart the boundary ahead of its advance. See for example Fig. 14, which shows such a crack that formed ahead of the corrosion or, in other words, developed in the alloy at a point farther than the corrosion had penetrated. This crack was free of corrosion and showed clean separation along the grain boundary. Its terminus, not visible in the photograph, was at the boundary of a third grain which evidently better resisted the internal stress.

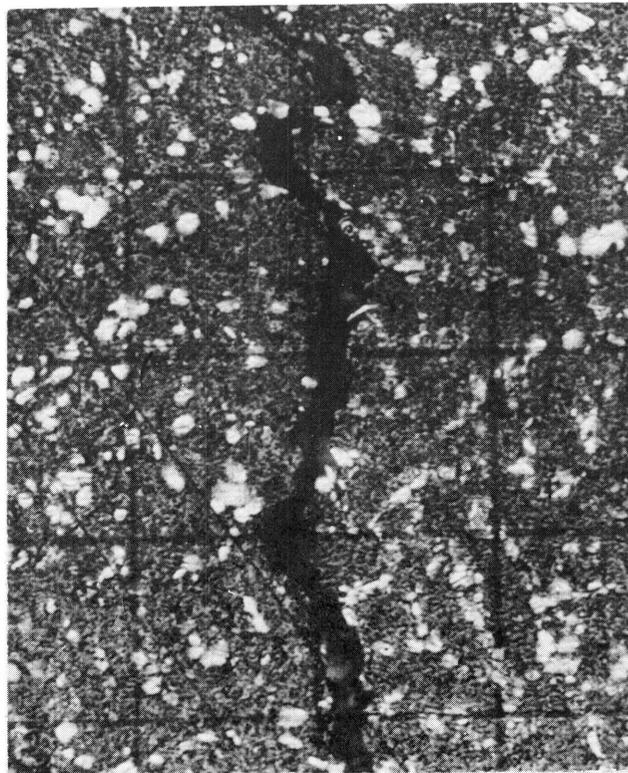
Fig. 14 - An example of interior stress cracking at a grain boundary. No corrosion is present. Lines forming the squares are 30 microns apart and the original magnification is 800X.

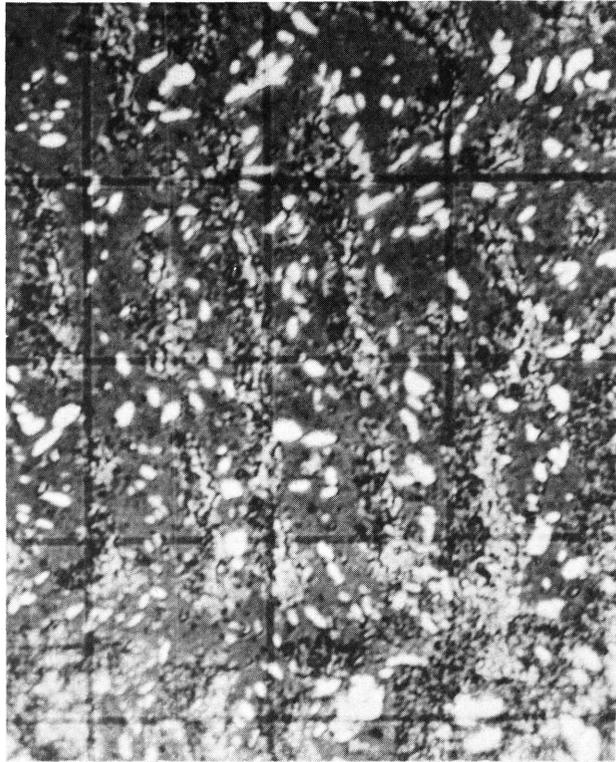
Fig. 15 - An example of interior stress cracking at an interdendritic boundary. Here corrosion is present as uniform gray material interspersed with bright antimony particles. The remaining portions of the primary lead dendrites appear as darker, two-toned areas without the bright antimony particles. Microcracks appear along the sides of the areas of primary dendrites. Lines forming the squares are 15 microns apart and the original magnification is 1500X.

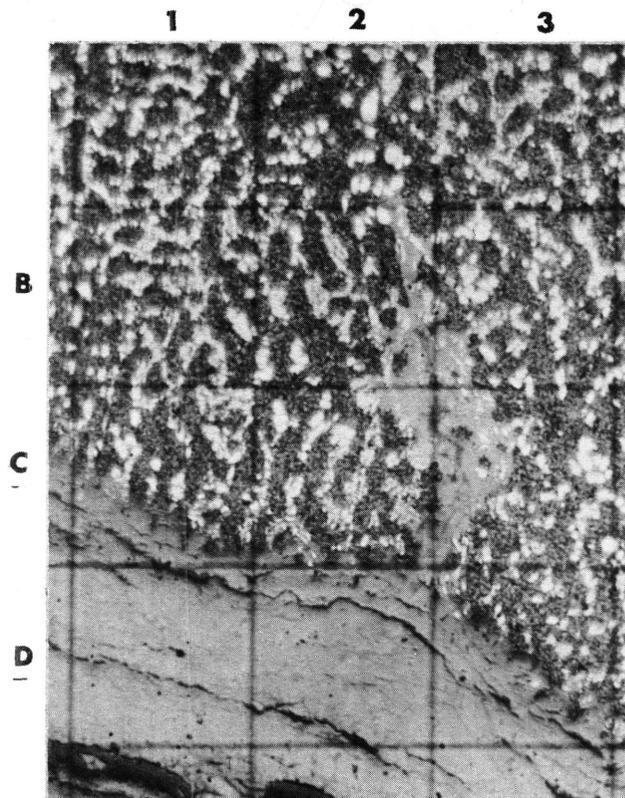
Fig. 17 - Typical beginning of grain boundary corrosion in a 7-year-old battery. The surface layer of corrosion is thick and dense. Lines forming the squares are 60 microns apart and the original magnification is 400X.

The method by which intergranular corrosion begins is perhaps better illustrated in the 7-year-old specimen. Examination of this grid revealed many areas such as that shown in Fig. 17. This corrosion is taking place along the line of junction of B2 and C2 with B3 and C3. Here there is no evidence of a crack either in the metal or in the corrosion product. The corrosion product formed along the grain boundary between the two adjacent grains evidently differs from that formed along the surface of the grid. Examination of the termination point of the corrosion in such an attacked grain boundary did not reveal any visible crack, and the grain boundary here appears no different from those that were not attacked (Fig. 16).

Figure 17 also shows that an elementary type of interdendritic corrosion takes place all along the grid surface underneath the corrosion layer and that here too there is a narrow zone where corrosion and antimony particles coexist.

Study of the 7-year-old battery indicated a large number of sites where intergranular corrosion was beginning (Fig. 17). A few such sites were characterized by much deeper penetration but no actual crack (Fig. 19). As has been mentioned, this type of grain boundary penetration was characteristically accompanied by small unattacked antimony particles (Fig. 18). The corrosion product also differed in appearance from the surface layer of corrosion (Figs. 3 and 4). In the usual anodic corrosion process antimony vanishes from the surface layer of metal with great rapidity and continues to vanish from each succeeding corroded layer as the corrosion product becomes thicker. In this way a very thick corrosion layer that is dense black when viewed by polarized light and contains no antimony particles can be built up. It has been observed, however, that when the corrosion layer is unusually thick or contains very few cracks a point is reached where corrosion and antimony particles exist together and a very mild interdendritic attack occurs all along the metal surface. In this region antimony particles will be found surrounded by areas of corrosion. As judged by the difference in relief level, this is also a softer material than the outer layers of corrosion.

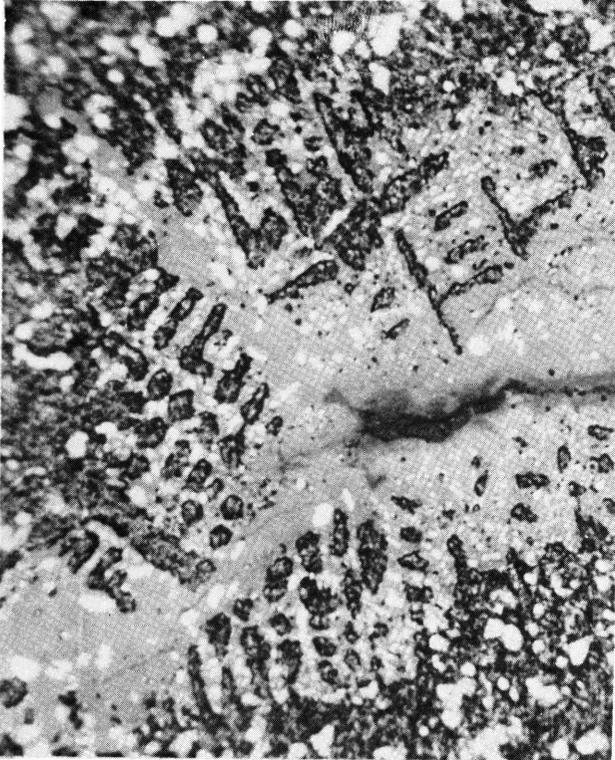
Fig. 18 - Typical interdendritic corrosion, proceeding nearly at right angles to the grain boundary that crosses the photograph near the center. The particles of undissolved antimony remain undisturbed where they were precipitated during freezing. Note the crack that has developed here a considerable distance within the metal. Original magnification is 800X.

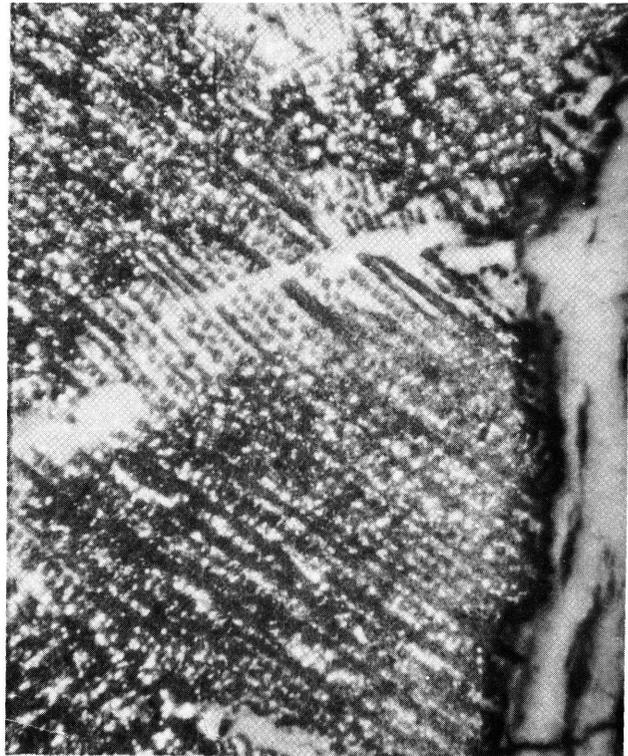
Fig. 19 - Example of an unusually extensive intergranular corrosion in the 7-year-old battery. Even with extensive interdendritic corrosion and consequent increase in volume in this area there has been no actual cracking. The interdendritic corrosion extends much farther between the primary dendrites adjacent to the grain boundary than at the metal surface, although the dendritic branches are all part of the same grain. Original magnification is 250X.

Figure 19 shows another example of grain boundary corrosion in which the penetration and the interdendritic penetration along the boundary are much deeper than in Fig. 17, although there is still no visible cracking. There is also evidence of interdendritic corrosion along the surface of the grid beneath the layer of corrosion product. However, although interdendritic alignment along the metal surface above the crack is the same as at the intergranular boundary, nowhere along the metal surface is there any such penetrating type of attack as that which occurs in the vicinity of the grain boundary. This can also be seen in Fig. 20, a view of the same area by polarized light. Near the surface

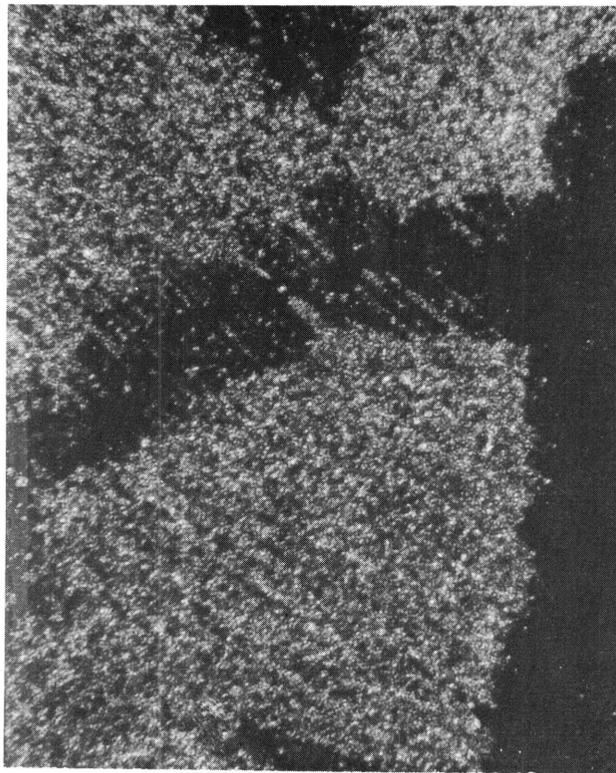
Fig. 20 - A view in polarized light of the same area as Fig. 19. The extensive nature of the interdentritic corrosion can be clearly seen. The darker line bisecting the interdentritic corrosion marks the position of the grain boundary with its included intergranular corrosion. Original magnification is 250X.

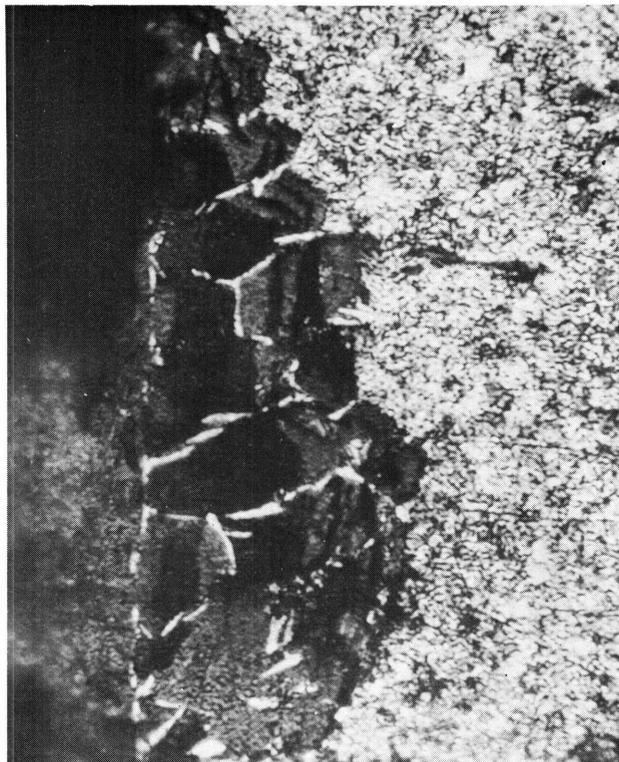
Fig. 21 - An example of the corrosion found on the surface of grids in unformed positive plates. Here the antimony particles are left undisturbed even at the surface, so that a line of antimony particles outlines the original surface as well as the dendritic boundaries. When formation begins these antimony particles will disappear and the corroded portion will be converted to PbO_2 . Original magnification is 1600X.

A similar type of corrosion in which antimony particles are not attacked proceeds inward from the surface of slowly dried but unformed plates. Here the attack is strictly chemical and results from the alkaline nature of the paste (Fig. 21). It will be noted that the individual bright antimony particles are left in their original positions, unattacked by the alkali. However, Fig. 22 (illuminated with polarized light) indicates that the corrosion product is translucent and certainly not an oxide, and its appearance in both photographs differs greatly from the product of the intergranular corrosion under discussion. It is believed that this case also indicates a reduced acidity and that under this circumstance and anodic attack the process becomes very selective for grain boundary and interdendritic attack of the lead solid solution and less destructive to the antimony particles.

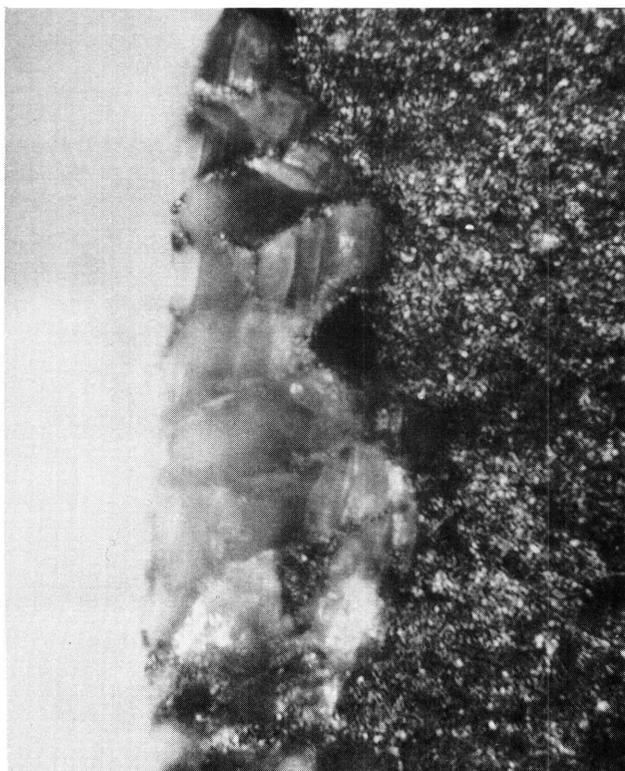
Fig. 22 - Same area as Fig. 21 but illuminated by polarized light. In this case the corrosion product is translucent. Note the odd striated structure of the corrosion product here and in Fig. 21. Original magnification is 1600X.
