**NRL Report 6045**

# **FLEXIBLE COAXIAL CABLE**

J. A. Guida

February 18, 1964

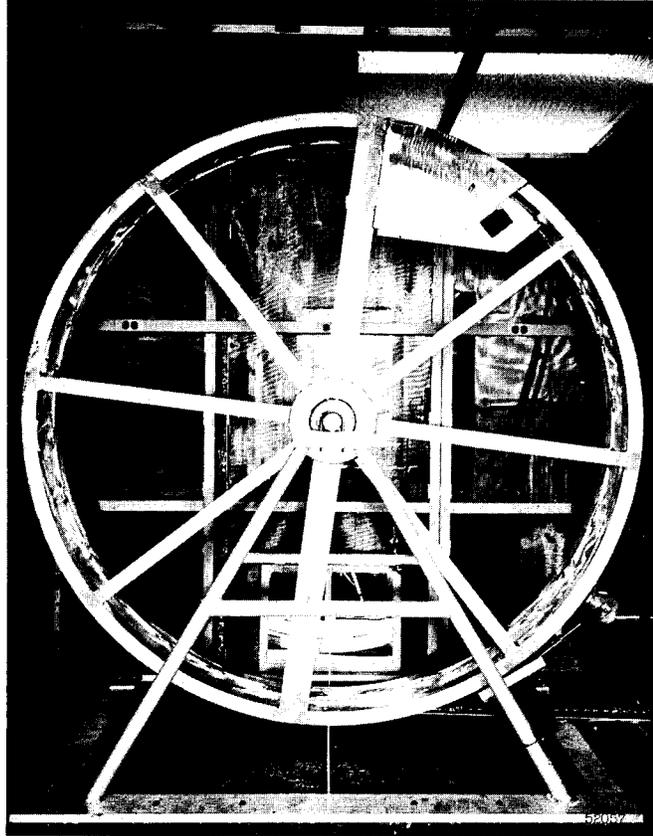
Fig. 1 - Aluminum wheel (7-ft diam) used to simulate the azimuth bearing of the proposed 600-ft antenna

The 600-ft antenna azimuth bearing was simulated by constructing a 7-ft-diam aluminum wheel (Fig. 1). The wheel was mounted in a screen room. The entire assembly is sketched in Fig. 2 and is shown in Fig. 3. A 1/2-hp reversing motor (Fig. 4) operated by limit switches drove the wheel. The coaxial cable under test was placed in series with the wheel drive. Cable tension was continually observed by spring balances in the cable drive (Fig. 5).

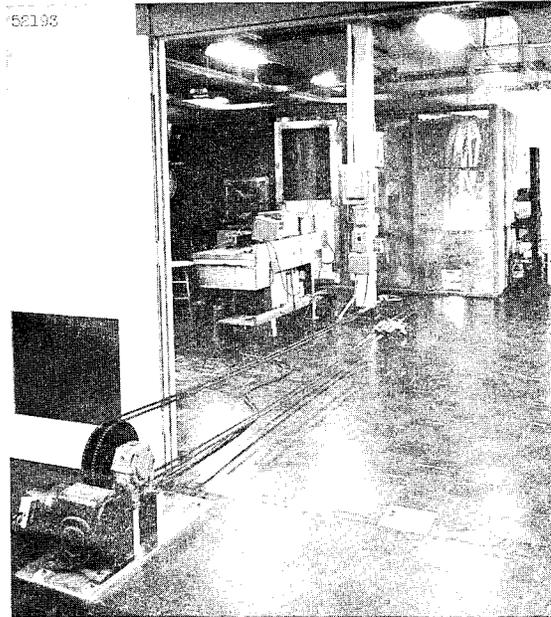
Fig. 3 - Working arrangement of azimuth simulator assembly

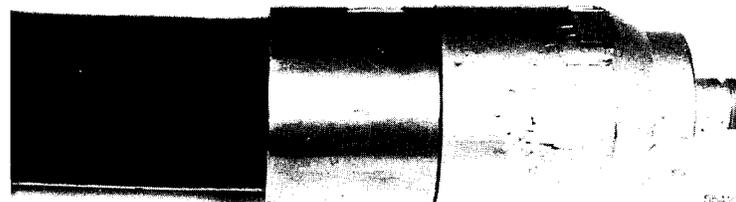
Fig. 20 - New design type N connectors for 7/8-in.-diam cable (top) and 1-5/8-in.diam cable (bottom)

Adaptors - The cable samples came equipped with EIA end connectors installed at the factory. To convert the 7/8-in.-diam cable end connector from EIA to type N required a transition from 7/8 in. to 1-5/8 in., then another 1-5/8-in. single-step adaptor to type N. This was required at each end of the cable. Including the factory installed end connector, a total of three pieces was needed at each cable end, as shown in Fig. 17. The sum total of all of these fittings raised havoc with the VSWR. Figure 18 shows the VSWR of the 1-5/8-in. EIA step adaptor to type N when mounted back to back and alone, as shown in Fig. 19(a). Figure 18 also shows the VSWR of the two precision step adaptors used to convert a 7/8-in. EIA to a type N connector. This also required three pieces. The precision adaptors used to convert to type N are shown in Fig. 19(b). Although these showed some improvement, the cable manufacturer at this point furnished new design end connectors and adaptors which now required only two items to go from cable to type N. These are shown installed in the 7/8-in.- and 1-5/8-in.-diam cables, Fig. 20.

VSWR Baseline, 1-5/8-In.-Diam Cable - An acceptable VSWR baseline for the 1-5/8-in.-diam cable, even with new connectors shown in Fig. 20, was not obtained up to the time the work was terminated, as is well shown in Fig. 24. The maximum frequency for this cable is given as 2800 Mc. The waveguide cutoff for a 91 percent velocity of propagation is 3000 Mc. However, from Fig. 24 it appears that use of this cable would be impracticable from 1800 Mc on up.
