NRL Report 5966

**AUTOMATIC WEATHER STATION
(GRASSHOPPER)
PART 1 - DESIGN AND MODIFICATIONS
1955-1961**

T. E. Marshall III

**U. S. NAVAL RESEARCH LABORATORY
Washington, D.C.**

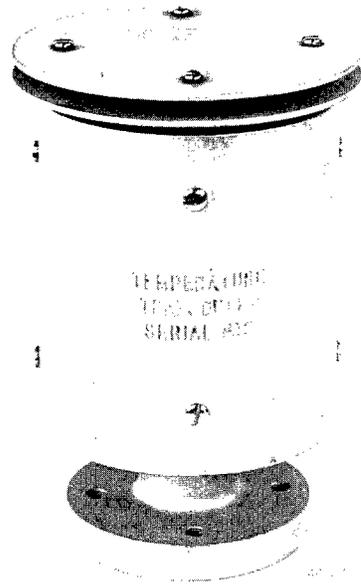
Fig. 16 - Thermoshield and temperature transducer

Fig. 17 - Thermoshield and temperature transducer

A special thermoshield was designed for the temperature transducer of the modified Grasshopper. A bimetal element with a 3-degree rotation for a temperature change of 1°F was selected to drive a rugged low-torque minitorque potentiometer (Fig. 16). These units were assembled on a thermoinsulated plate which was supported in a well-ventilated tubular housing. A second ventilated tubular-radiation shield was installed outside the first unit giving a double-shield effect. Two cover plates were provided, separated with spacers to give ventilation and act as thermal insulators. This unit was mounted on a supporting pedestal which carries the electrical plug-in feature. A complete unit is shown in Fig. 17. The plug-in feature made the unit convenient to install on the top deck of the Grasshopper as shown in Fig. 18. When the temperature transducer and thermoshield were tested continuously on the Grasshopper for four days under varying conditions such as cloudy nights, clear nights, bright sunshine, overcast, rain, and winds up to 20 knots, the telemetered data showed a maximum deviation of $\pm 1\frac{1}{2}^{\circ}\text{F}$ from the weather bureau's observed values. Four of the above temperature transducers and thermoshields were supplied to Deepfreeze with calibration charts and installation instructions.

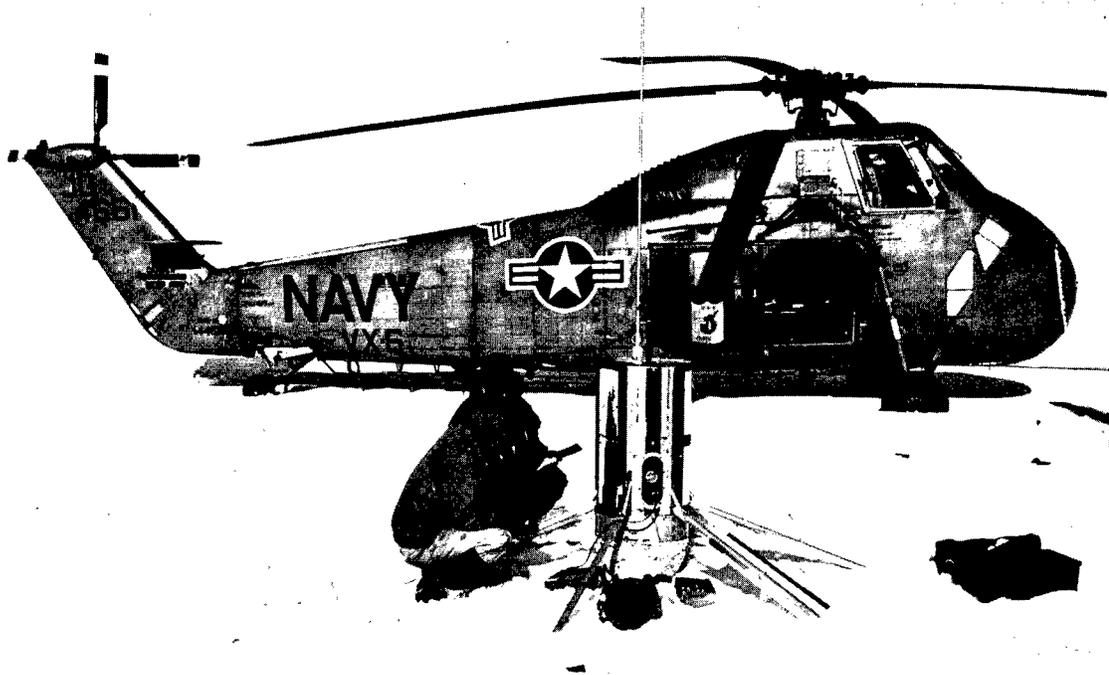
Fig. 29 - Placing Grasshopper in service on Ross Ice Shelf at Antarctica (Season 1960)

Grasshoppers (NAFI Nos. 3 and 6), which were modified at NRL, did not arrive until late in the season. A Grasshopper being placed in service on the Ross Ice Shelf is shown in Fig. 29.

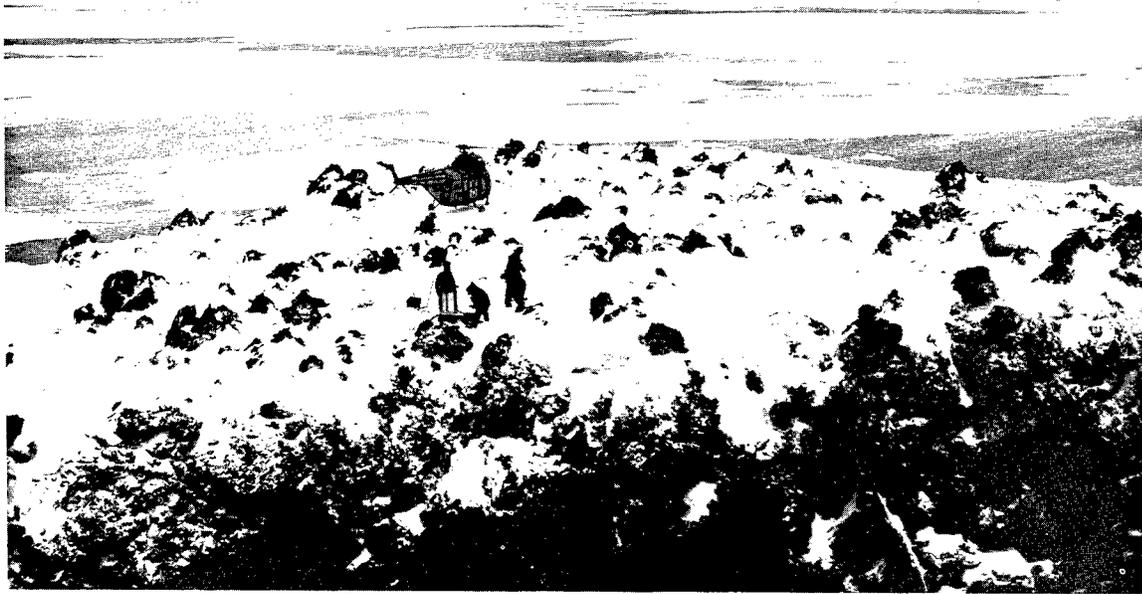
Fig. 32 - Placing Grasshopper in service on Scott Island (Season 1962)

Modified station NAFI No. 1 arrived at McMurdo Station in time to be placed on Scott Island on Nov. 13, 1961 (Figs. 32 and 33). This station was heard only several times. When an investigation was made on Dec. 26, 1961, the antenna was found collapsed. The antenna was extended and the station appeared to work. However, the station was heard only several times again. This station was returned to McMurdo Station on Feb. 10, 1962, and the antenna was found shorted from salt water which entered the antenna while it was collapsed, thereby causing the failure of the station. This station was installed at Beardmore (since the manned weather station there was vacated during the winter) with sufficient batteries for the winter season (Fig. 31). It operated intermittently over the five-month period and was heard for 300 miles. The intermittent reception was linked with lubricant freezing since it was heard whenever the temperature would rise above -40°F . The temperature transducer became inoperative and was believed to have filled with snow. This was a severe test of the station and the experiment was considered encouraging.
