NRL Report 6809

# Surface Chemical Methods of Displacing Water and/or Oils and Salvaging Flooded Equipment

## Part 6 - Field Experience in Removing Seawater Salt Residues from Aircraft Cockpits and Avionics Equipment

December 12, 1968

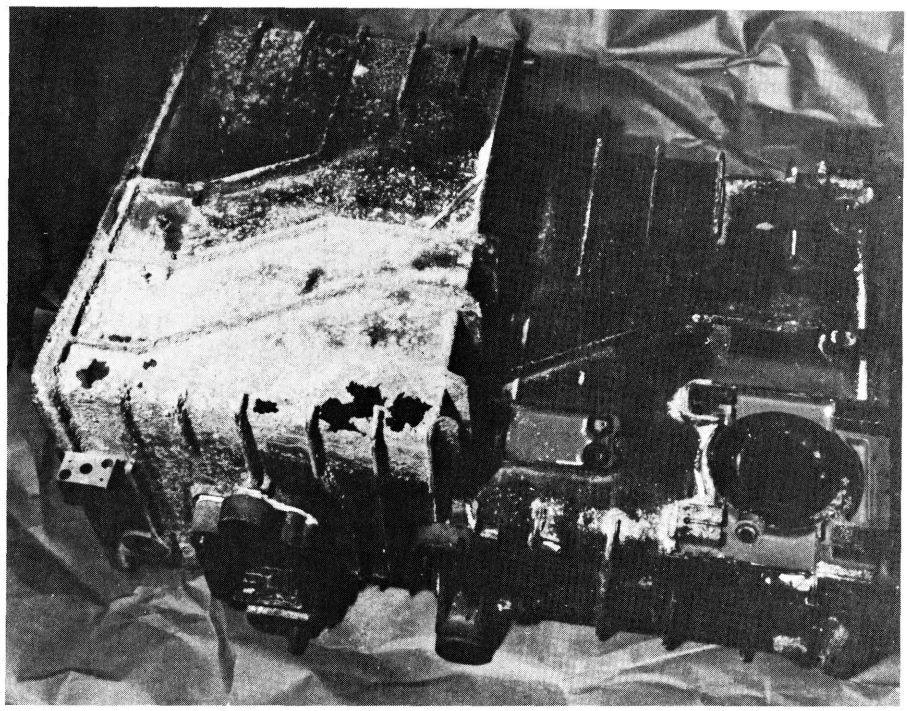
After the aircraft and their avionics equipment had been received by the rework facilities, NRL personnel were requested to assist in the cleaning and recovery phase. On examination of the material received at Cherry Point and Jacksonville, it was found that the equipment that had been properly preserved was in easily salvable condition, with little corrosion. The equipment which had been thoroughly washed with fresh water but not properly preserved was generally in good condition but suffered some corrosion damage. Some aircraft cockpits and their fittings and wiring were in this category. Unfortunately, many items of electrical and electronic equipment had apparently not been rinsed in fresh water and had obviously not been coated with any preservative or had been only externally coated. Extensive corrosion had taken place, particularly on units having magnesium chassis or cases or other active galvanic couples to promote corrosion (16), (Figs. 1 and 4). Corrosion-damaged parts are usually beyond restoration by any cleaning process and require more expensive refinishing or replacement.

Fig. 1 - Magnesium case severely corroded by saltwater. (Photograph courtesy of Naval Air Rework Facility, Jacksonville, Florida.)

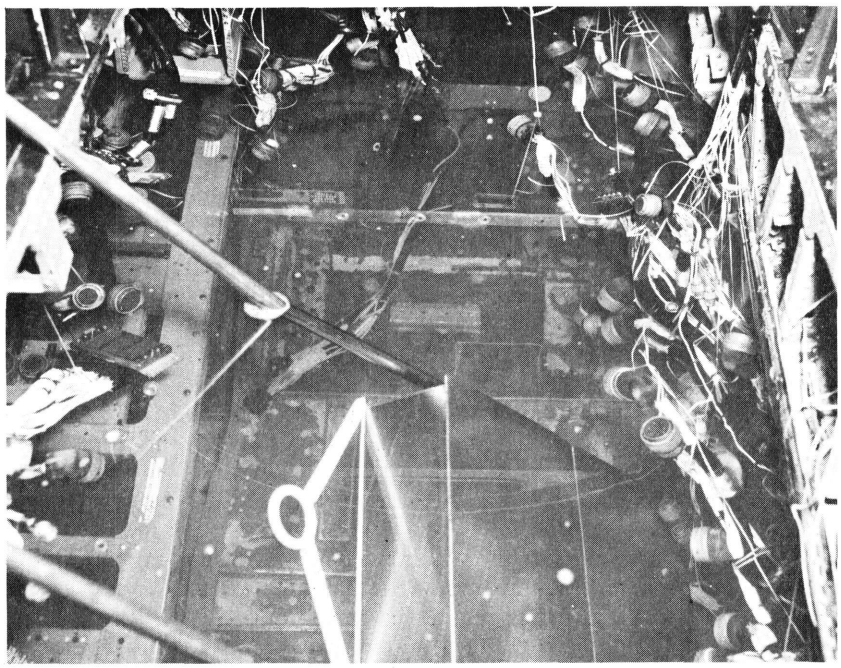
Fig. 2 - Forward end of rear cockpit during cleaning, with ultrasonic transducers immersed in detergent solution. (Photographs courtesy of Naval Air Rework Facility, Cherry Point, North Carolina.)

After the cockpits were filled with the cleaning solution, the transducers were placed in the cockpits and energized (Fig. 2). Note that the transducers were mounted in pairs on frames with lifting eyes for easier handling and positioning. The assemblies were near neutral bouyancy under water. The transducers were ordered with the power lead conduits connected to them by right-angle fittings so that they could be arranged horizontally with one above the other to form an array 14 in. wide and 22 in. high. The transducers were moved about in the cockpits so that the ultrasonic energy, which is emitted only from the transducer faces opposite the supporting framework, was applied to all areas of the cockpits. During the time when ultrasonic energy is being absorbed by the gases dissolved in the water, the intensity of energy at the surfaces to be cleaned is low. Cleaning was therefore continued for 15 min beyond the time when the degassing action diminished. After the cleaning solution had been pumped out, the cockpits were sprayed with fresh water, filled with water, and rinsed with ultrasonic agitation. This step is necessary to remove the cleaning solution which has been driven deep into crevices. The rinse water was then pumped out and sucked from nondraining pockets.

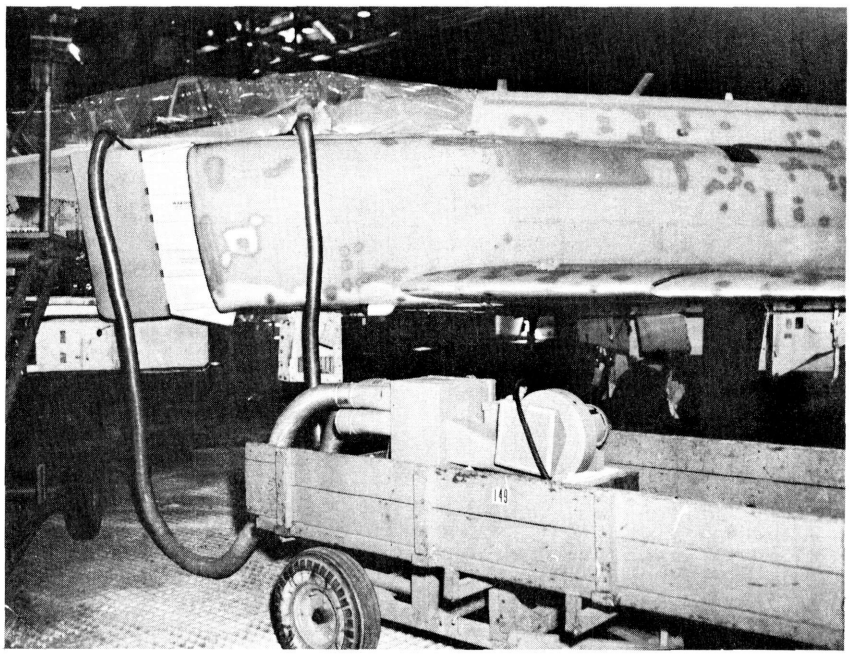
Fig. 3 - Drying the cockpits with warm air

thoroughly over everything in the cockpits. Air at 130°F was then blown into the cockpits by a hot-air integral fuel cell blower. The doors and plates which had been used to make the cockpits watertight were removed to allow air to exhaust, and plastic film was taped over the canopy openings (Fig. 3).

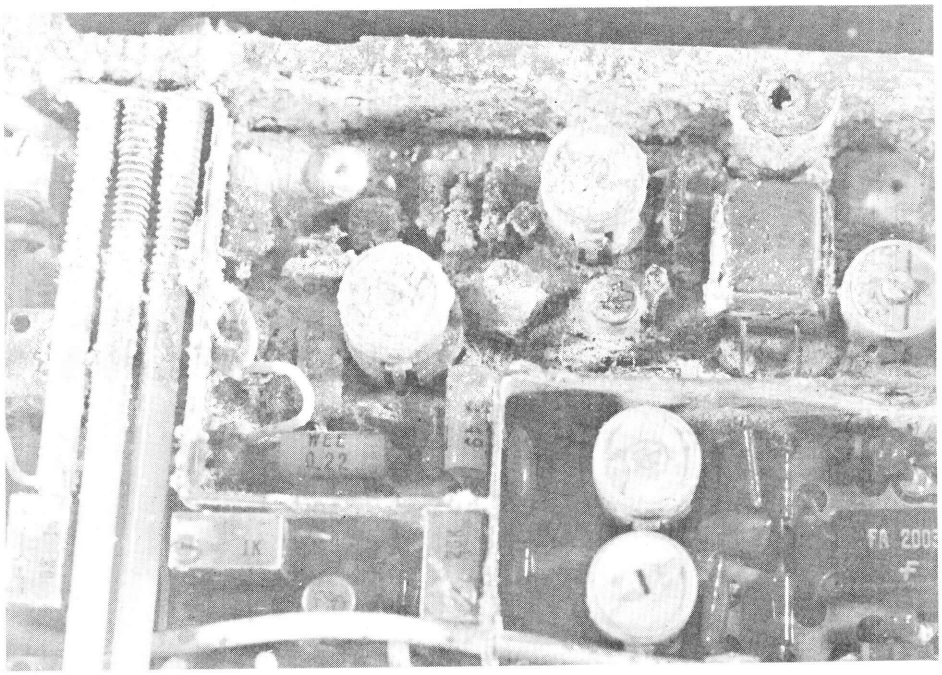
Fig. 4 - Electronic unit, showing salt residue and corrosion products before cleaning. (Photographs courtesy of Naval Air Rework Facility, Jacksonville, Florida.)

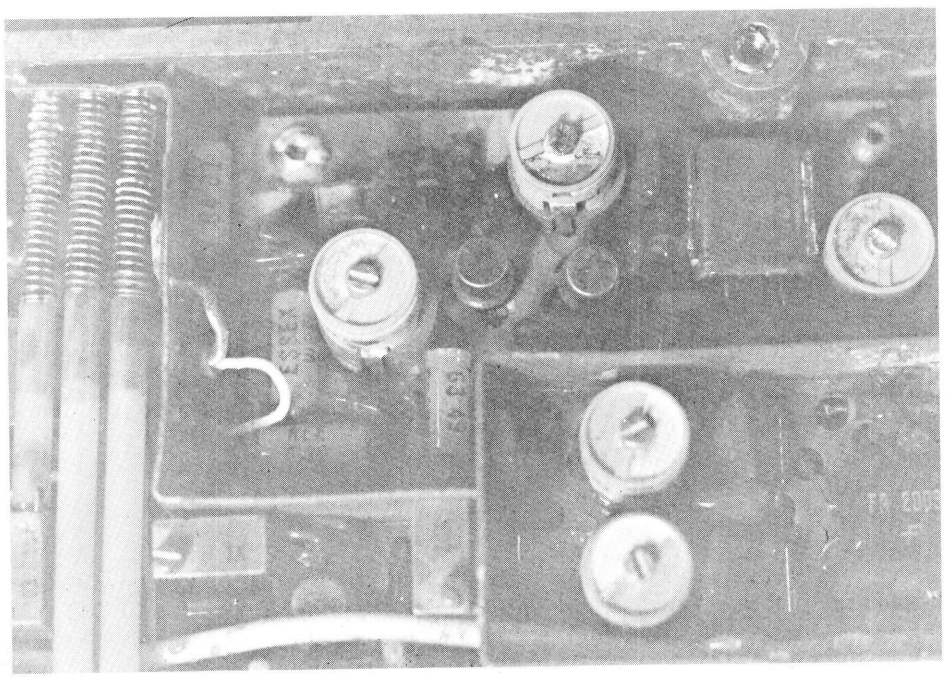
Fig. 5 - Unit shown in Fig. 4, after ultrasonic cleaning

On completion of the cockpit cleaning and rinsing the transducer assemblies were placed in tanks fabricated so that the assemblies covered one end of the tanks below the level of the liquid, and the length was sufficient to accommodate the largest units to be cleaned. One tank was used for cleaning and one for rinsing. The same detergent solution was used for cleaning as was used in the cockpit cleaning. After cleaning and rinsing, the units were sprayed with Spra-Dri (Type II) and placed in an oven at 125°F to dry. The equipment was then bench checked, corroded parts were replaced, and necessary repairs were made. An electronic unit, shown in Fig. 4 contaminated with salt water and badly corroded, is shown in Fig. 5 after having been cleaned ultrasonically for about 5 min, rinsed, and dried.
