NRL Report 8139

The Refrigeration-11 Plant— An Evaluation of Residue Formation and Chemical Cleaning Methods

August 30, 1977

NAVAL RESEARCH LABORATORY
Washington, D.C.

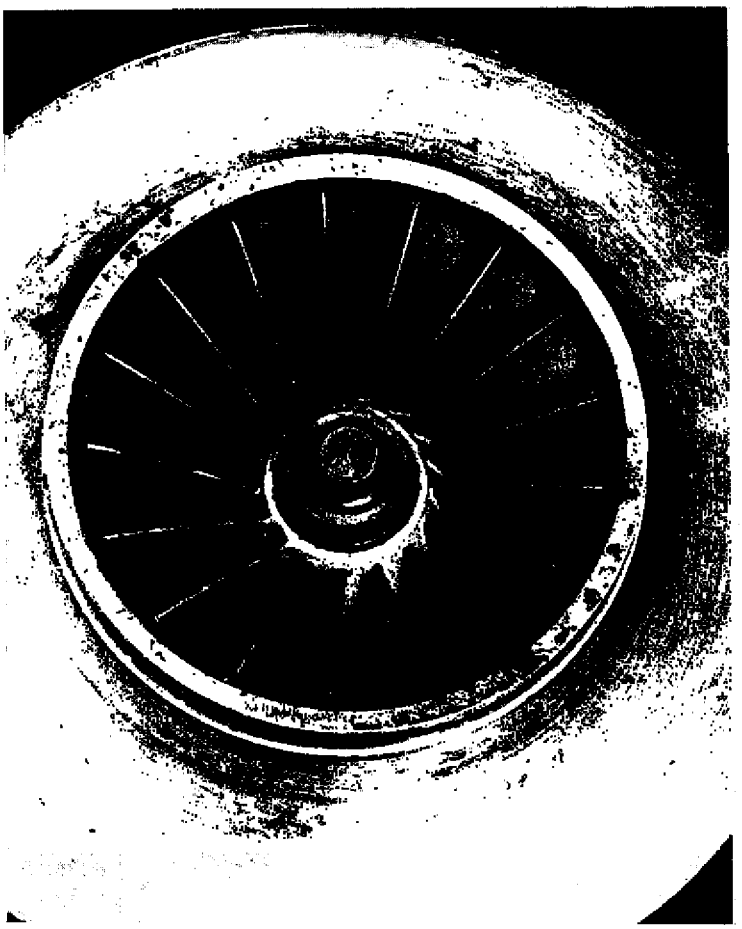
An impeller (Fig. 1) from an R-11 plant showed alternate layers of red and gray deposits, indicating possible formation of FeO, Fe_2O_3, and Fe_3O_4. A heterogenous rusty brown residue was obtained by physically scraping the deposits from various parts of the R-11 plant (Fig. 2).

Fig. 1 — Impeller with buildup of solid residue

3. Analysis of the residue and the deposits on an R-11 plant impeller indicated high concentrations of aluminum, copper, and iron.

6. It appears that a cleaning solution containing Oakite 32 would most effectively solubilize the plant residue and would also be the most compatible cleaner for the metal components in the R-11 plant. However, a large-scale engineering test should be made to confirm this conclusion. Further, the EDTA slurry should be included in such a test for comparison.

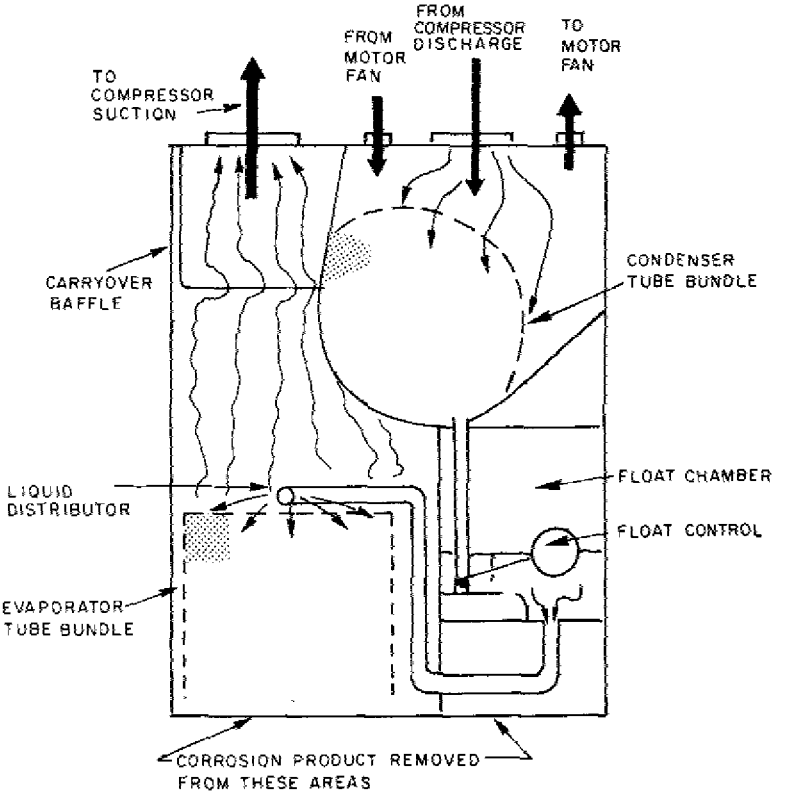
Fig. 2 — Cross section of triduty shell
