NAVAL RESEARCH LABORATORY
Washington, D. C.

RADIO DIVISION II - RECEIVER SECTION

SUPERHETERODYNE RECEPTION
A STUDY OF VARIOUS LOOP
COUPLING METHODS

- Report R-2872

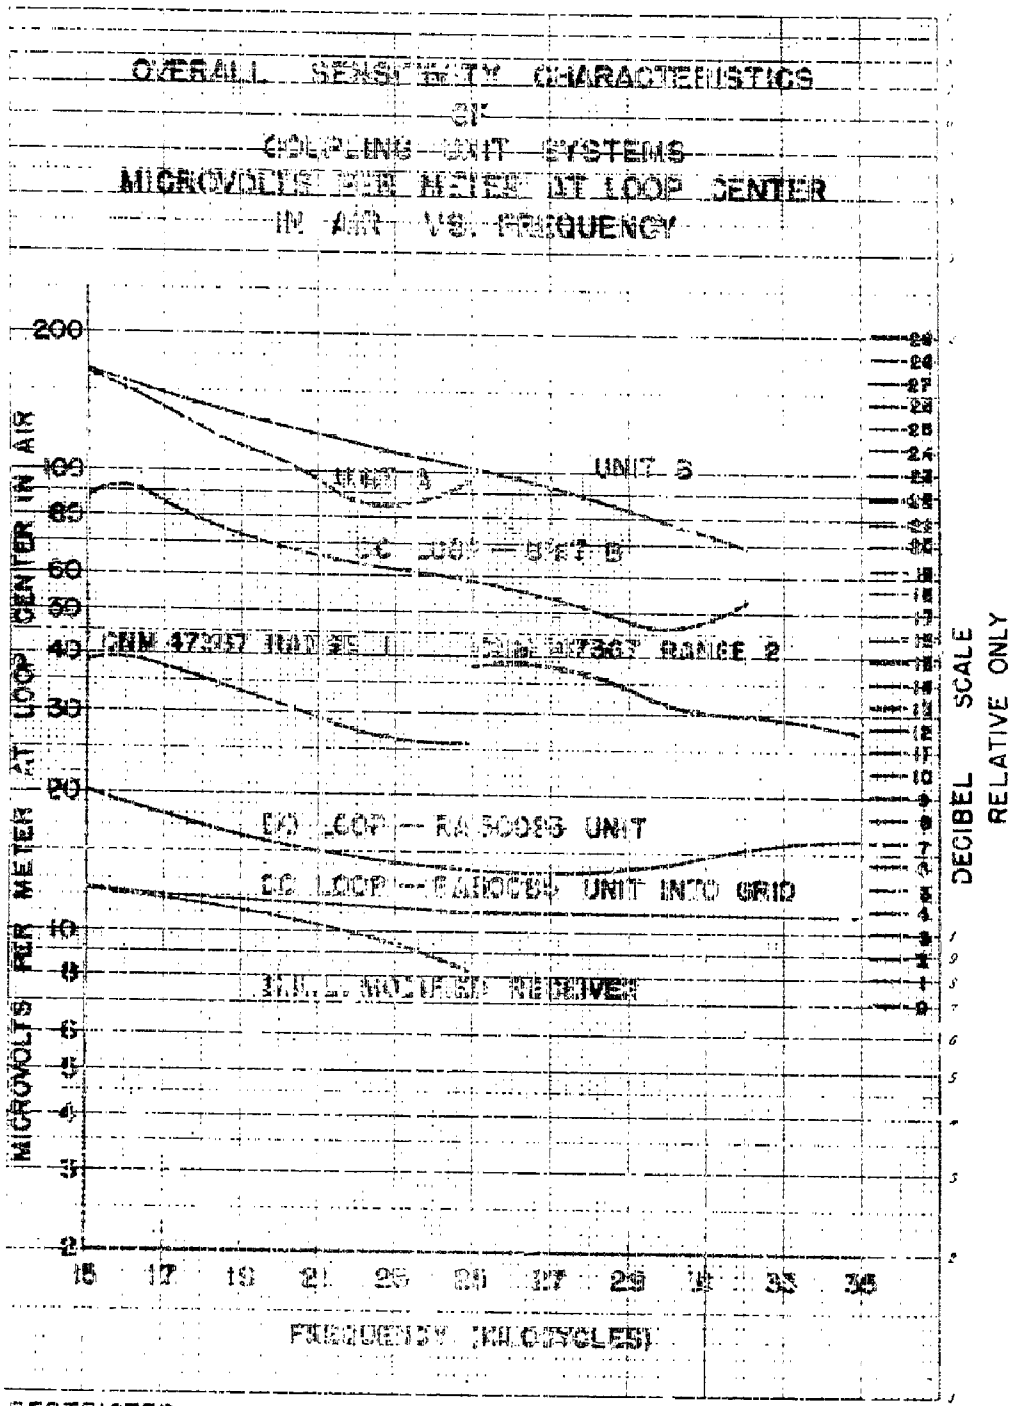
5. The sensitivity of the overall system (CNM 66097 Loop, Mare Island Coupling Unit B, and RAK Receiver) varied from 163 microvolts per meter at 15 Kilocycles to 79 microvolts per meter at 30 Kilocycles. At 25 Kilocycles the sensitivity value was 102 microvolts per meter (Reference Plate 1). The overall sensitivity using the CNM-47367 Coupling Unit varied from 38 microvolts per meter at 15 Kilocycles to 31 microvolts per meter at 30 Kilocycles. The overall sensitivity using the modified Model RAK Receiver (incorporating NRL transformer design, reference 3), varied from 12.2 microvolts per meter at 15 Kilocycles to 8.2 microvolts per meter at 25 Kilocycles. These data indicate that the present standard CNM 66097 system, using the CNM-47367 Coupling Unit, is about 13 decibels at 15 Kilocycles and about 6 decibels at 30 Kilocycles better than the system using the Mare Island Coupling Units. When the comparison is carried further, it is found that the NRL proposed system using the modified Model RAK Receiver and CNM 66097 Loop is about 23 decibels at 15 Kilocycles and about 21 decibels at 25 Kilocycles better than the system using the Mare Island Coupling Units. Proposed in reference (3), this system modification is understood to be in process of adoption.

8. The curves shown on Plate 1 indicate that neither Mare Island Coupling Unit has a frequency range of 15 to 35 Kilocycles. Unit A frequency coverage lies between 15 and 25 Kilocycles [illegible] Unit B between 15 and 32 Kilocycles.

OVERALL SENSITIVITY CHARACTERISTICS
OF
COUPLING UNIT SYSTEMS
MICROVOLTS PER METER AT LOOP CENTER
IN AIR VS. FREQUENCY
MICROVOLTS PER METER AT LOOP CENTER IN AIR
200
100
80
60
50
40
30
20
10
8
6
5
4
3
2
UNIT 5
RANGE 2
DC LOOP — RA 50083 UNIT
DC LOOP — RA50083 UNIT INTO GRID
15
17
19
21
23
25
27
29
31
33
35
FREQUENCY (KILOCYCLES)
DECIBEL SCALE
RELATIVE ONLY
