# A Reliable Piezoelectric Ballistic Impact Detector

L. E. IVEY AND T. A. HENRIQUEZ

25 October 1973

**NAVAL RESEARCH LABORATORY**  
Underwater Sound Reference Division  
P.O. Box 8337, Orlando, Fla. 32806

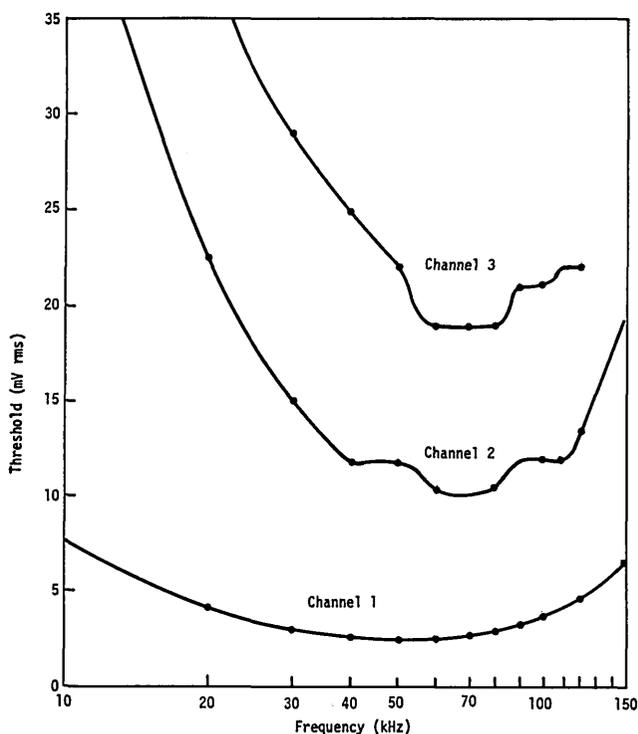
Fig. 1. Threshold voltages of input amplifier channels (1-cycle pulse).

It was necessary first to determine the approximate ranges of various parameters of the existing and required transducers. The input amplifier response was measured by inserting a 1-cycle sinusoidal pulse and increasing the pulse amplitude until the electronic system indicated a hit. Figure 1 shows threshold voltage amplitude as a function of frequency for the three ranges of attenuation provided by the amplifier to compensate for various sizes of projectiles. Results of some preliminary accelerometer measurements on the test range indicated that most of the unwanted noise picked up by the existing detection system was in the frequency range below 10 kHz. Specific acoustic impedance ( $\rho c$ ) and quality factor for samples of plywood and polyethylene target materials then were measured with a Brüel and Kjaer complex modulus apparatus (Table I). Results of the attenuation measurements for transverse and longitudinal waves in polyethylene are shown in Fig. 2.

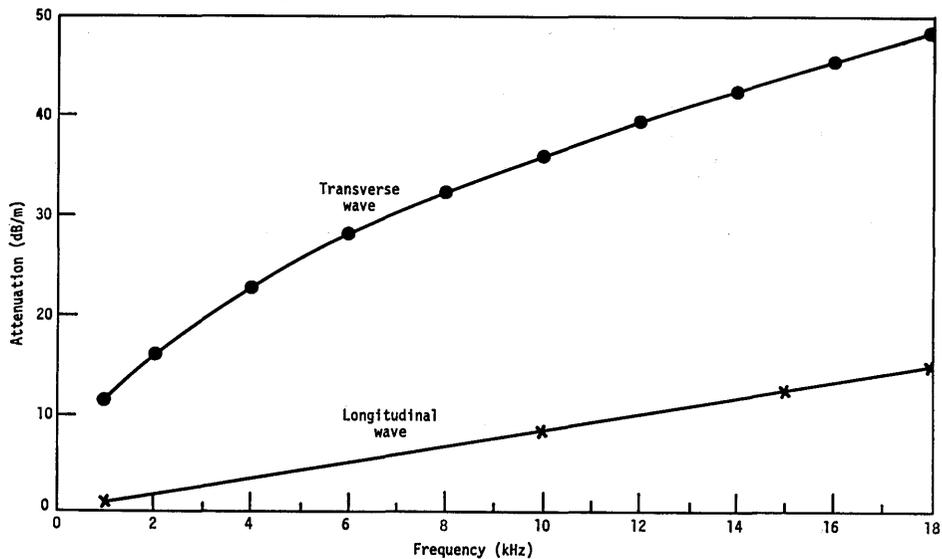
Fig. 2. Attenuation of longitudinal and transverse waves in polyethylene target material;  $Q = 30$  at  $22^\circ\text{C}$ .

Two types of waves were considered in the analysis of target response characteristics because projectile impacts cause the target to respond transversely, thus exciting transverse (bending) waves; penetration by a projectile also causes expansion of the target material, setting up longitudinal (compressional) waves away from the point of impact [1,2].

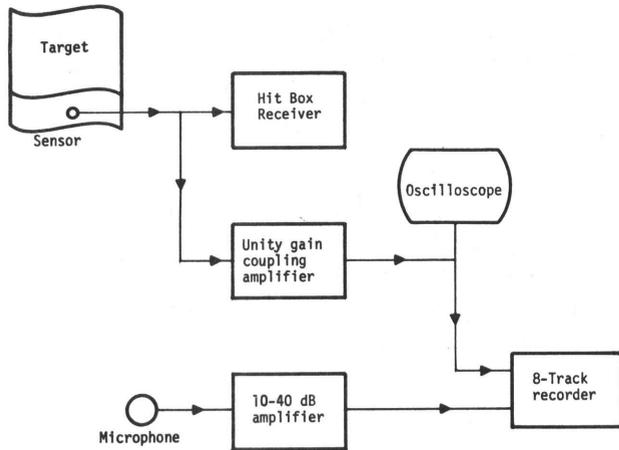
Fig. 3. Block diagram of hit detector instrumentation.

All USRD measurements of responses to ballistic impacts were made at the small arms range of McCoy Air Force Base and the Marco Gun Club of Orlando. Because it was not possible to investigate all possible target and shooting conditions at these sites, a limited test program was designed to measure the physical responses of the targets, the present sensor, and new experimental sensors to impulses generated by high-velocity 30-06 projectiles fired from a range of 100 yd. A block diagram of the instrumentation used for these measurements is shown in Fig. 3. Figure 4 shows a typical range installation of a group of experimental sensors on the bottom foot of a target, with the hit-scoring unit located nearby. Figure 5 shows the storage oscilloscope, the eight-track instrumentation recorder, and other equipment used during a test run.

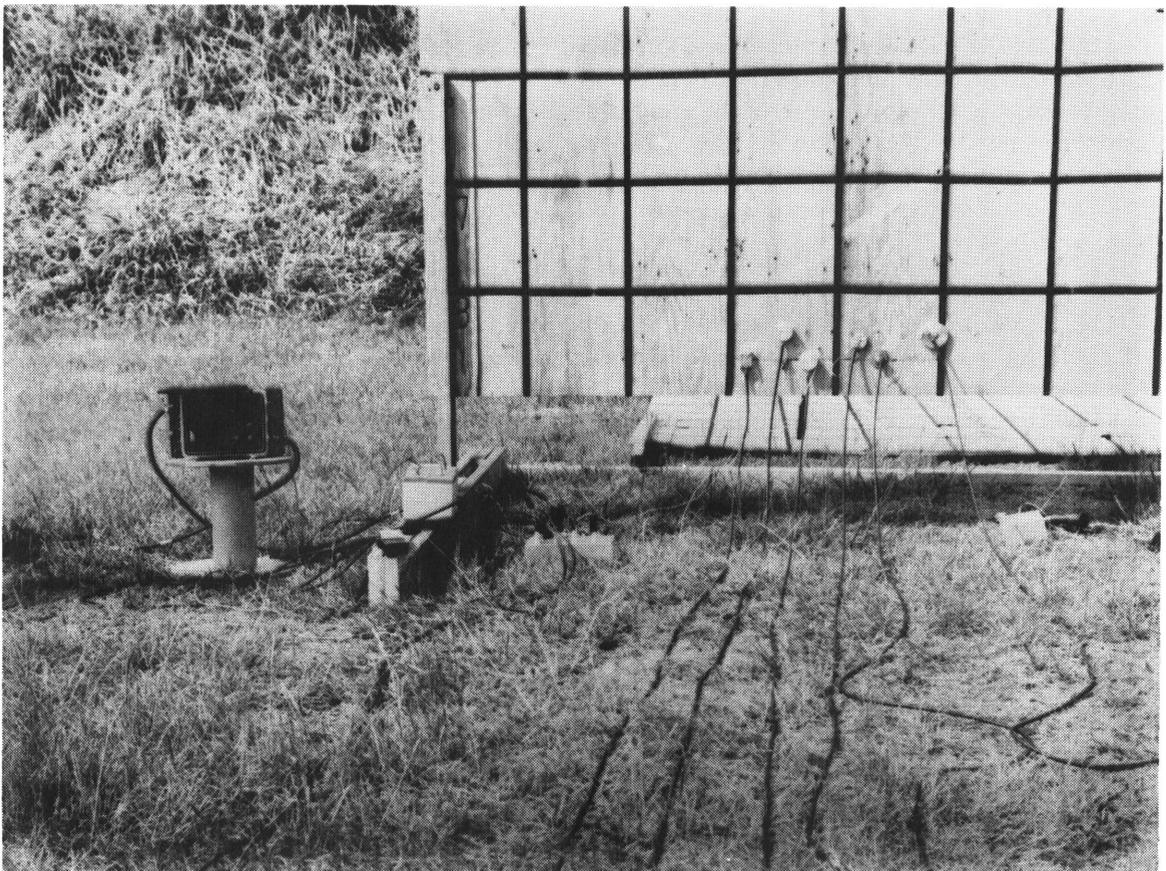
Fig. 4. Typical target installation. Transducers are mounted in bottom row of the target; scoring unit is at left.

The same general procedure was used for both the preliminary tests with the plywood target and later tests with the polyethylene target. One-foot squares were marked off on the target with electrical tape to facilitate identification of impact areas, and the sensors were fastened to the target in the bottom row as shown in Figs. 4 and 6. After the instrumentation was connected, an expert marksman called out one of the target square numbers and fired at least one round at it; after each shot, an observer (with a spotting telescope focused on the indicator light of the hit-scoring unit) made an oral report of the result and another observer checked the target through his telescope and reported which square was hit. Oral reports were recorded on the voice channel of the data tape, and the sensor data were recorded on the remaining AM channels (to at least 50 kHz). Samples of sensor data also were recorded by the storage oscilloscope for subsequent analyses of signal levels and duration.

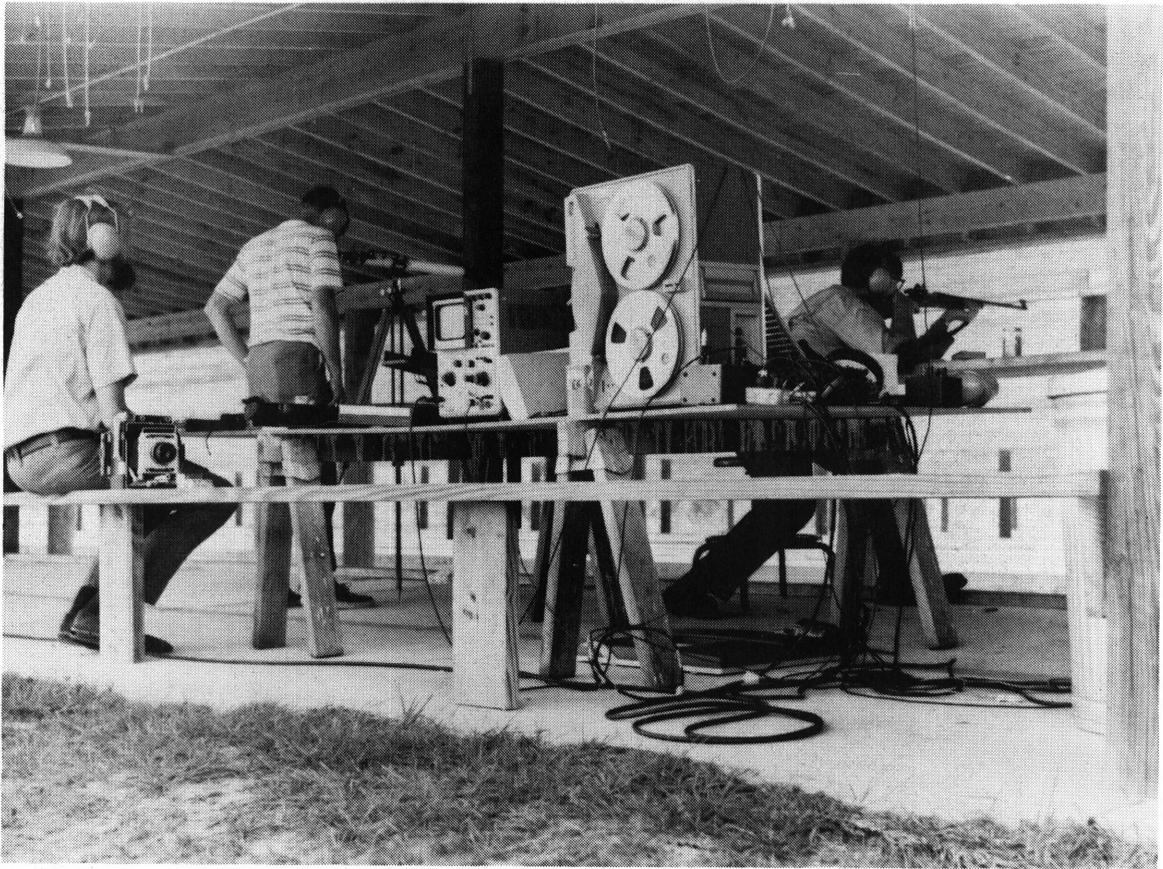
Fig. 5. Hit box instrumentation near the test range firing line.

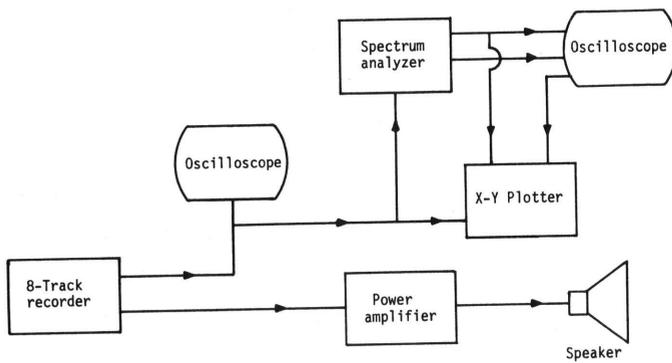
Fig. 7. Block diagram for spectral analysis of hit detector data.

The combined impulse response of the target and the sensor was determined by observing the results from the sensor data tape on the screen of the storage oscilloscope, converting selected data from the time domain to frequency domain by a Federal Scientific Ubiquitous UA14 Analyzer, and plotting the results with an X-Y plotter (Fig. 7). Reference signals of 1.0 and 0.5 V at 10 and 15 kHz, respectively, were recorded at the beginning of each data tape track to provide absolute output values. The channel 4 voice monitor was used to aid in establishing the identification of each pulse shot.

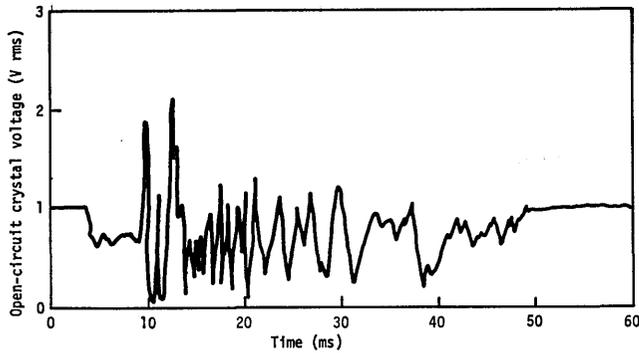
Fig. 8. Time function for 30-06 projectile impacts in target column 5.

A typical time function and the associated frequency spectrum for a projectile impact on the target as detected by the X10 sensor are shown in Figs. 8 and 9. Figure 10 shows the relationships between the vertical distances from points of impact to the sensor and the amplitudes of the characteristic frequency peaks (10, 12.5, and 15 kHz) observed in the X10 spectra for these measurements. It appears that the 10-kHz frequency peak is the best indicator of the vertical position of a hit because interference caused by reflections from the edges of the target was less pronounced. Attenuation coefficients were computed for selected data points that appeared in Fig. 8 to be least affected by boundary conditions. Normalized attenuation for the frequencies 10, 12.5, and 15 kHz shown in Fig. 11 are in reasonable agreement with the calculated values shown in Fig. 2. This procedure shows that meaningful information can be obtained from samples of various target materials to establish transducer design criteria so that the extent of testing can be minimized.

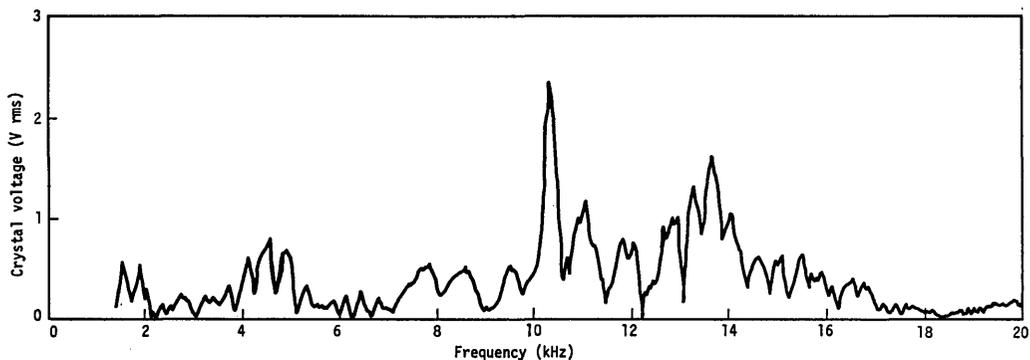
Fig. 9. Frequency spectrum for 30-06 projectile impacts in target column 5.

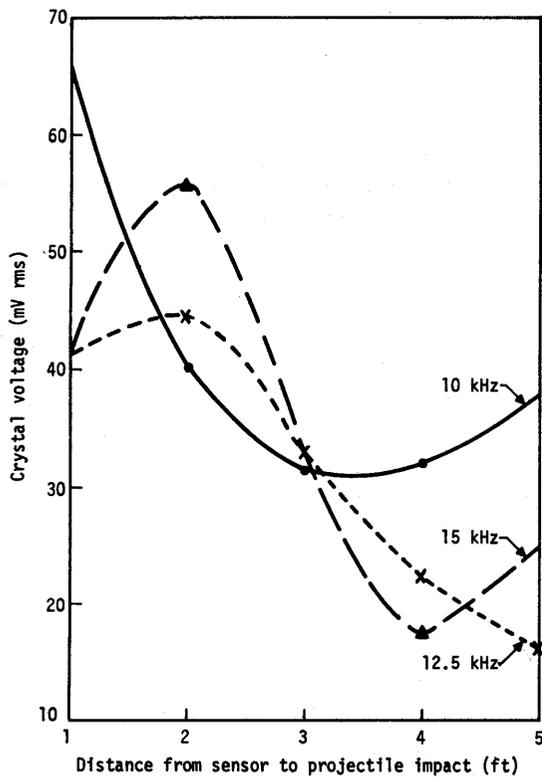
Fig. 10. Open-circuit crystal voltage response of G39 sensor at various vertical distances from points of projectile impacts.

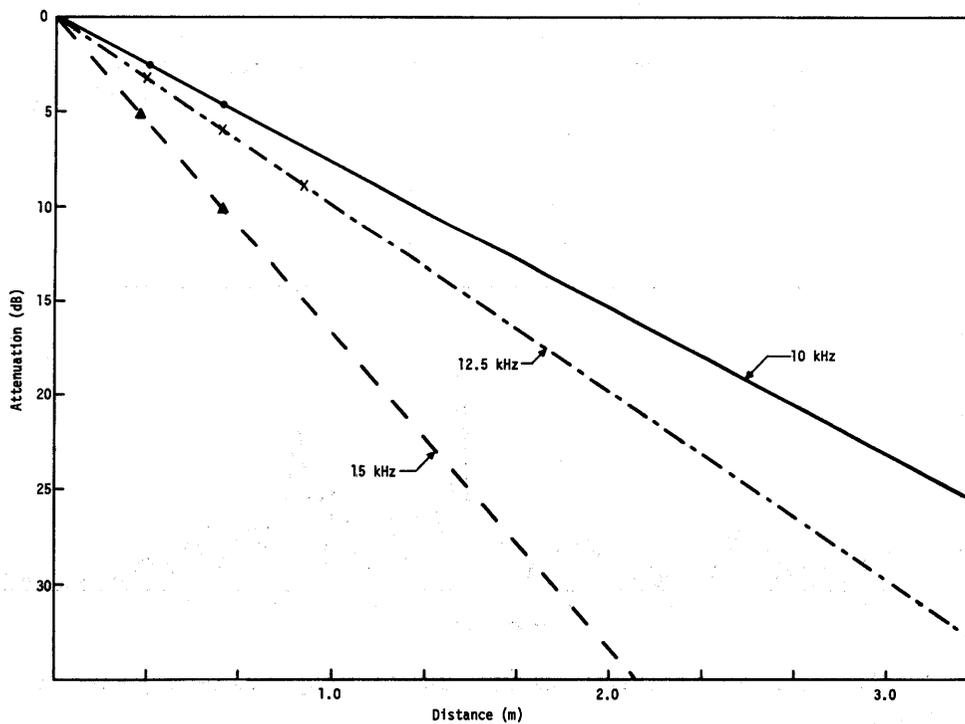
Fig. 11. Normalized attenuation as a function of distance for the frequencies 10, 12.5, and 15 kHz.

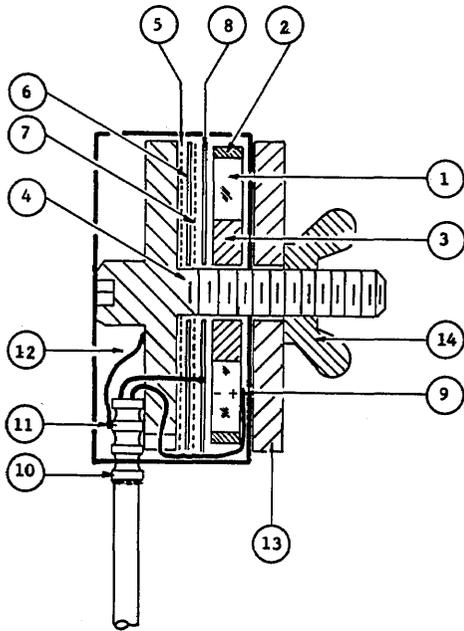
Fig. 12. Sectional view of USRD type G39 transducer: (1) ferroelectric ceramic element, (2) Corprene outer ring, (3) Corprene inner ring, (4) mounting subassembly, (5) epoxy resin, (6) fiberglass resin, (7) epoxy resin, (8) negative electrode foil, (9) positive electrode foil, (10) cable assembly, (11) copper ferrule, (12) epoxy resin, (13) stainless-steel washer, (14) wingnut.

Figure 12 is a sectional view of experimental sensor X10, which is officially designated USRD type G39 transducer. This assembly consists of three separable units that are taken apart as shown in Fig. 13, then reassembled for mounting on a target: transducer section, stainless-steel washer, and stainless-steel wingnut. The transducer

section includes the ceramic element, insulation, and electrical connectors encapsulated in epoxy potting resin together with the mounting subassembly, which is fashioned from a stainless-steel washer silver-soldered to the shoulder of a 3/8-24x1½ in. Allen-head machine bolt. Corprene cylinders fitted closely to the inner and outer cylindrical surfaces of the ceramic element provide acoustical shielding, but permit the element to vibrate or deform freely with minimal damping. Mechanical parameters of the epoxy resin closely approximate those of the new polyethylene target, thus assuring maximum coupling of impact pulses from the target to the sensitive element.

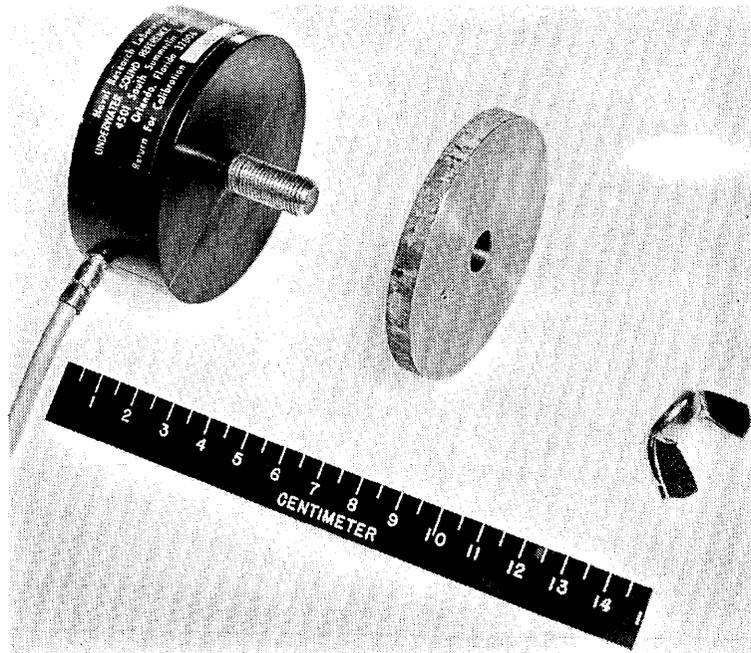
Fig. 13. USRD type G39 transducer.

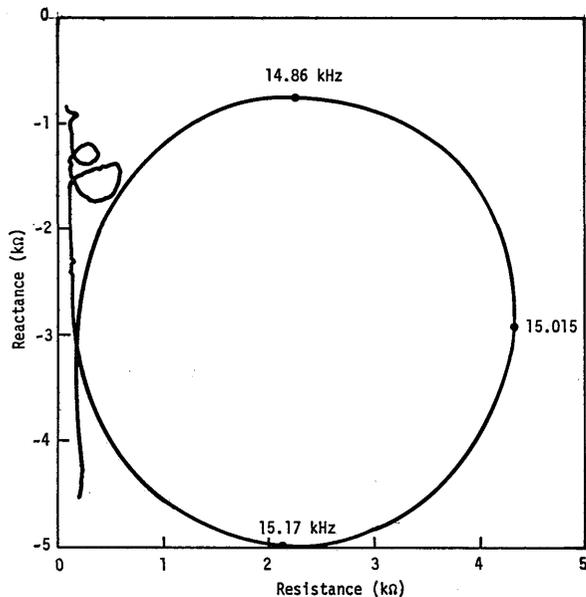
Fig. 14. Typical impedance of G39 transducer (without external mounting washer).

Electrical measurements of the G39 at the end of the standard 3-m cable indicate the following resistances: high lead to low lead, >30 GΩ; high lead to shield, >10 GΩ; and low lead to shield, >10 GΩ. The capacitance measured with a 1-kHz bridge has a nominal value of 3354 pF from the high side to the low side, with a dissipation of <1%. The resonance frequency and typical impedance for the G39 (without external mounting washer) are shown in Fig. 14.
